## **Refurbishment Survey (with MA only)**

**33 THE CRESCENT  
BRIMINGTON,  
S43 1AZ**

***Chesterfield Borough Council***

Job Number: J124650

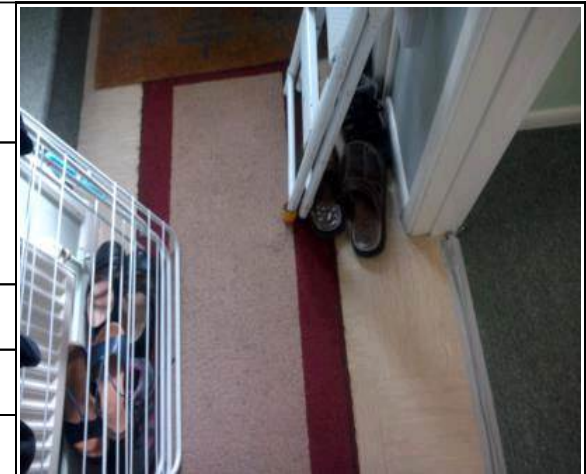
Inspection Number:	1	Intrusive Area – Yes or No:	Yes
Item:	Detail:	Item:	Detail:
<b>Material Assessment</b>		<b>Priority Risk Assessment</b>	
Building:	B1 / 2 Bedroom House	Location:	N/A
Location:	Ground / Hall G01	Accessibility:	N/A
Sample Number:	CX000759	Extent / Amount:	N/A
Description:	Hall - Floor	Normal Occupant Activity:	N/A
Position:	floor tiles under new floor tiles	Secondary Occupant Activity:	N/A
Extent:	2m <sup>2</sup>	Number of Occupants:	N/A
Product Type:	Reinforced Composite	Frequency of Use of Area:	N/A
Damage & Deterioration:	Low Damage	Average Time Area in Use:	N/A
Surface Treatment:	Composite materials containing asbestos	Maintenance Type:	N/A
Asbestos Type:	Chrysotile	Frequency of Maintenance Activity:	N/A
Material Score:	3	Priority Score:	0

Room Comments:	plasterboard ceiling new vinyl floor tiles to brown floor tiles to concrete brick and plaster walls
Sample Comments:	N/A
Total Assessment Score:	3
Risk Assessment Category:	Very Low
Recommendation:	Remove ACM if within the scope of works for refurbishment

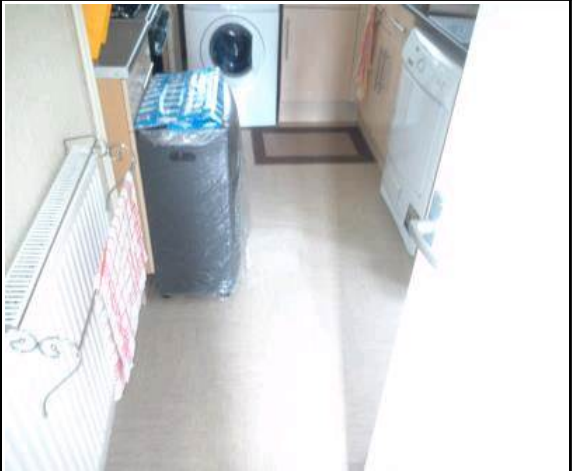
Inspection Number:	2	Intrusive Area – Yes or No:	Yes
Item:	Detail:	Item:	Detail:
<b>Material Assessment</b>		<b>Priority Risk Assessment</b>	
Building:	B1 / 2 Bedroom House	Location:	N/A
Location:	Ground / Kitchen G02	Accessibility:	N/A
Sample Number:	AS CX000759	Extent / Amount:	N/A
Description:	Kitchen - Floor	Normal Occupant Activity:	N/A
Position:	floor tiles under new floor tiles	Secondary Occupant Activity:	N/A
Extent:	8m <sup>2</sup>	Number of Occupants:	N/A
Product Type:	Reinforced Composite	Frequency of Use of Area:	N/A
Damage & Deterioration:	Low Damage	Average Time Area in Use:	N/A
Surface Treatment:	Composite materials containing asbestos	Maintenance Type:	N/A
Asbestos Type:	Chrysotile	Frequency of Maintenance Activity:	N/A
Material Score:	3	Priority Score:	0

Room Comments:	plasterboard ceiling new vinyl floor tiles to brown floor tiles to concrete brick and plaster walls

Sample Comments:	N/A	
Total Assessment Score:	3	
Risk Assessment Category:	Very Low	
Recommendation:	Remove ACM if within the scope of works for refurbishment

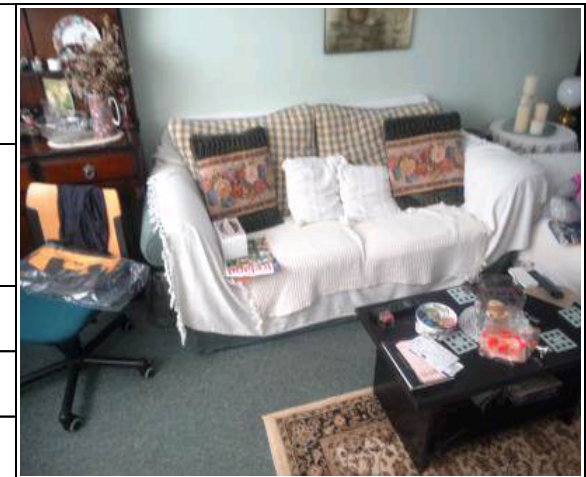
Inspection Number:	3	Intrusive Area – Yes or No:	Yes
Item:	Detail:	Item:	Detail:
<b>Material Assessment</b>		<b>Priority Risk Assessment</b>	
Building:	B1 / 2 Bedroom House	Location:	N/A
Location:	Ground / Living Room G03	Accessibility:	N/A
Sample Number:	CX000760	Extent / Amount:	N/A
Description:	Living Room - Floor	Normal Occupant Activity:	N/A
Position:	floor tiles under carpet	Secondary Occupant Activity:	N/A
Extent:	15m <sup>2</sup>	Number of Occupants:	N/A
Product Type:	Reinforced Composite + Well Bound Material	Frequency of Use of Area:	N/A
Damage & Deterioration:	Low Damage	Average Time Area in Use:	N/A
Surface Treatment:	Composite materials containing asbestos	Maintenance Type:	N/A
Asbestos Type:	Chrysotile	Frequency of Maintenance Activity	N/A
Material Score:	3	Priority Score:	0

Room Comments:	plasterboard ceiling carpet to vinyl floor ties to concrete brick and plaster walls
Sample Comments:	N/A
Total Assessment Score:	3
Risk Assessment Category:	Very Low
Recommendation:	Remove ACM if within the scope of works for refurbishment

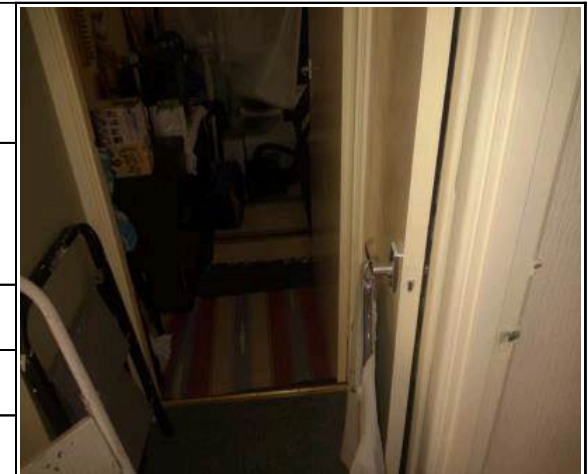
Inspection Number:	4	Intrusive Area – Yes or No:	Yes
Item:	Detail:	Item:	Detail:
<b>Material Assessment</b>		<b>Priority Risk Assessment</b>	
Building:	B1 / 2 Bedroom House	Location:	N/A
Location:	First / Hall 101	Accessibility:	N/A
Sample Number:	Visual	Extent / Amount:	N/A
Description:	Hall - Whole Area	Normal Occupant Activity:	N/A
Position:	no suspect material	Secondary Occupant Activity:	N/A
Extent:		Number of Occupants:	N/A
Product Type:		Frequency of Use of Area:	N/A
Damage & Deterioration:	N/A	Average Time Area in Use:	N/A
Surface Treatment:	N/A	Maintenance Type:	N/A
Asbestos Type:		Frequency of Maintenance Activity:	N/A
Material Score:	0	Priority Score:	0

Room Comments:	plasterboard ceiling carpet to wood floor brick and plaster walls
Sample Comments:	N/A
Total Assessment Score:	0
Risk Assessment Category:	N/A
Recommendation:	Not applicable

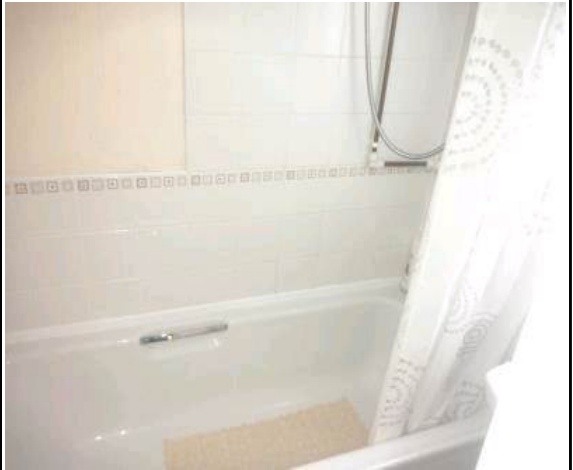
Inspection Number:	5	Intrusive Area – Yes or No:	Yes
Item:	Detail:	Item:	Detail:
<b>Material Assessment</b>		<b>Priority Risk Assessment</b>	
Building:	B1 / 2 Bedroom House	Location:	N/A
Location:	First / Bathroom 102	Accessibility:	N/A
Sample Number:	Visual	Extent / Amount:	N/A
Description:	Bathroom - Whole Area	Normal Occupant Activity:	N/A
Position:	no suspect material	Secondary Occupant Activity:	N/A
Extent:		Number of Occupants:	N/A
Product Type:		Frequency of Use of Area:	N/A
Damage & Deterioration:	N/A	Average Time Area in Use:	N/A
Surface Treatment:	N/A	Maintenance Type:	N/A
Asbestos Type:		Frequency of Maintenance Activity:	N/A
Material Score:	0	Priority Score:	0

Room Comments:	plasterboard ceiling vinyl floor covering to wood brick and plaster walls

Sample Comments:	N/A	
Total Assessment Score:	0	
Risk Assessment Category:	N/A	
Recommendation:	Not applicable

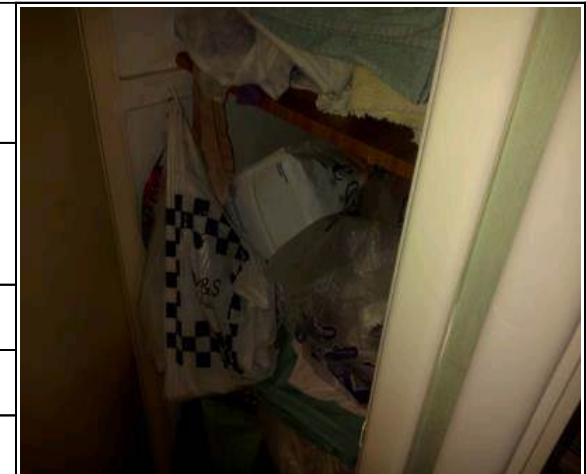
Inspection Number:	6	Intrusive Area – Yes or No:	Yes
Item:	Detail:	Item:	Detail:
<b>Material Assessment</b>		<b>Priority Risk Assessment</b>	
Building:	B1 / 2 Bedroom House	Location:	N/A
Location:	First / Cupboard 103	Accessibility:	N/A
Sample Number:	Visual	Extent / Amount:	N/A
Description:	Cupboard - Whole Area	Normal Occupant Activity:	N/A
Position:	no suspect material	Secondary Occupant Activity:	N/A
Extent:		Number of Occupants:	N/A
Product Type:		Frequency of Use of Area:	N/A
Damage & Deterioration:	N/A	Average Time Area in Use:	N/A
Surface Treatment:	N/A	Maintenance Type:	N/A
Asbestos Type:		Frequency of Maintenance Activity:	N/A
Material Score:	0	Priority Score:	0

Room Comments:	plasterboard ceiling carpet to wood floor brick and plaster walls
Sample Comments:	N/A
Total Assessment Score:	0
Risk Assessment Category:	N/A
Recommendation:	Not applicable

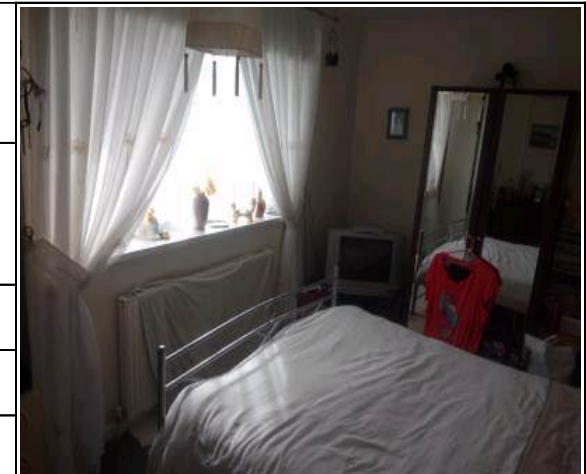
Inspection Number:	7	Intrusive Area – Yes or No:	Yes
Item:	Detail:	Item:	Detail:
<b>Material Assessment</b>		<b>Priority Risk Assessment</b>	
Building:	B1 / 2 Bedroom House	Location:	N/A
Location:	First / Bed 1 104	Accessibility:	N/A
Sample Number:	Visual	Extent / Amount:	N/A
Description:	Bed 1 - Whole Area	Normal Occupant Activity:	N/A
Position:	no suspect material	Secondary Occupant Activity:	N/A
Extent:		Number of Occupants:	N/A
Product Type:		Frequency of Use of Area:	N/A
Damage & Deterioration:	N/A	Average Time Area in Use:	N/A
Surface Treatment:	N/A	Maintenance Type:	N/A
Asbestos Type:		Frequency of Maintenance Activity:	N/A
Material Score:	0	Priority Score:	0

Room Comments:	plasterboard ceiling carpet to wood floor brick and plaster walls
Sample Comments:	N/A
Total Assessment Score:	0
Risk Assessment Category:	N/A
Recommendation:	Not applicable

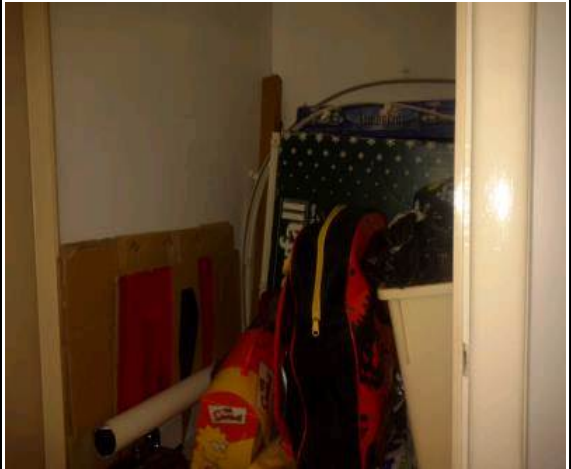
<b>Inspection Number:</b>	8	<b>Intrusive Area – Yes or No:</b>	Yes
<b>Item:</b>	<b>Detail:</b>	<b>Item:</b>	<b>Detail:</b>
<b>Material Assessment</b>		<b>Priority Risk Assessment</b>	
Building:	B1 / 2 Bedroom House	Location:	N/A
Location:	First / Cupboard 106	Accessibility:	N/A
Sample Number:	Visual	Extent / Amount:	N/A
Description:	Cupboard - Whole Area	Normal Occupant Activity:	N/A
Position:	no suspect material	Secondary Occupant Activity:	N/A
Extent:		Number of Occupants:	N/A
Product Type:		Frequency of Use of Area:	N/A
Damage & Deterioration:	N/A	Average Time Area in Use:	N/A
Surface Treatment:	N/A	Maintenance Type:	N/A
Asbestos Type:		Frequency of Maintenance Activity:	N/A
Material Score:	0	Priority Score:	0

Room Comments:	plasterboard ceiling floor brick and plaster walls

Sample Comments:	N/A	
Total Assessment Score:	0	
Risk Assessment Category:	N/A	
Recommendation:	Not applicable

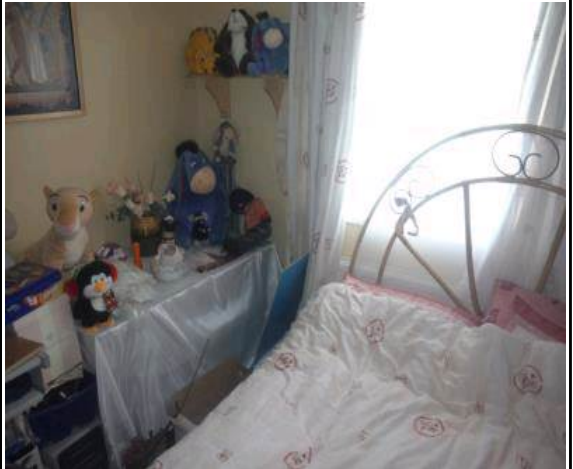
Inspection Number:	9	Intrusive Area – Yes or No:	Yes
Item:	Detail:	Item:	Detail:
<b>Material Assessment</b>		<b>Priority Risk Assessment</b>	
Building:	B1 / 2 Bedroom House	Location:	N/A
Location:	First / Bed 2 105	Accessibility:	N/A
Sample Number:	Visual	Extent / Amount:	N/A
Description:	Bed 2 - Whole Area	Normal Occupant Activity:	N/A
Position:	no suspect material	Secondary Occupant Activity:	N/A
Extent:		Number of Occupants:	N/A
Product Type:		Frequency of Use of Area:	N/A
Damage & Deterioration:	N/A	Average Time Area in Use:	N/A
Surface Treatment:	N/A	Maintenance Type:	N/A
Asbestos Type:		Frequency of Maintenance Activity:	N/A
Material Score:	0	Priority Score:	0

Room Comments:	plasterboard ceiling carpet to wood floor brick and plaster walls

Sample Comments:	N/A	
Total Assessment Score:	0	
Risk Assessment Category:	N/A	
Recommendation:	Not applicable

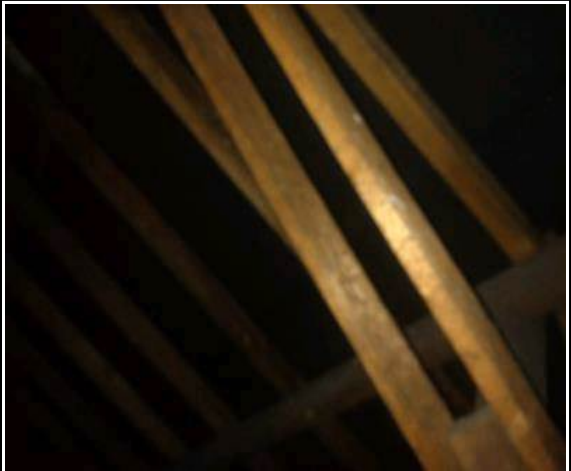
Inspection Number:	10	Intrusive Area – Yes or No:	Yes
Item:	Detail:	Item:	Detail:
<b>Material Assessment</b>		<b>Priority Risk Assessment</b>	
Building:	B1 / 2 Bedroom House	Location:	N/A
Location:	Roof / Loft R01	Accessibility:	N/A
Sample Number:	CX000761	Extent / Amount:	N/A
Description:	Loft - Ceiling	Normal Occupant Activity:	N/A
Position:	Roof felt	Secondary Occupant Activity:	N/A
Extent:	60m <sup>2</sup>	Number of Occupants:	N/A
Product Type:	Well Bound Material	Frequency of Use of Area:	N/A
Damage & Deterioration:	Low Damage	Average Time Area in Use:	N/A
Surface Treatment:	Composite materials containing asbestos	Maintenance Type:	N/A
Asbestos Type:	No Asbestos Detected	Frequency of Maintenance Activity	N/A
Material Score:	0	Priority Score:	0

Room Comments:	fibre glass insulation roof felt

Sample Comments:	N/A	
Total Assessment Score:	0	
Risk Assessment Category:	N/A	
Recommendation:	Not applicable

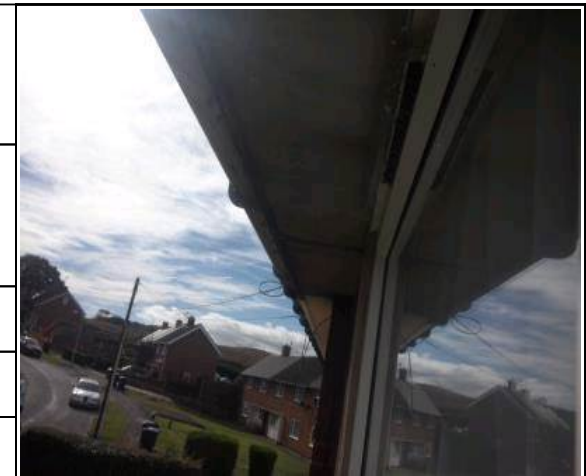
11	B1 / 2 Bedroom House	External / Whole Property E01	CX000762	1 Roof External - External General Outdoors	16lm	Asbestos Cement (1)	Low Damage (1)	Surface Sealed (1)	Chrysotile (1) Crocidolite (3)	Low (6)	0	6	Remove ACM if within the scope of works for refurbishment

Inspection Number:	11	Intrusive Area – Yes or No:	Yes
Item:	Detail:	Item:	Detail:
<b>Material Assessment</b>		<b>Priority Risk Assessment</b>	
Building:	B1 / 2 Bedroom House	Location:	N/A
Location:	External / Whole Property E01	Accessibility:	N/A
Sample Number:	CX000762	Extent / Amount:	N/A
Description:	Roof External - External General	Normal Occupant Activity:	N/A
Position:	soffits to front and rear are cement	Secondary Occupant Activity:	N/A
Extent:	16lm	Number of Occupants:	N/A
Product Type:	Asbestos Cement	Frequency of Use of Area:	N/A
Damage & Deterioration:	Low Damage	Average Time Area in Use:	N/A
Surface Treatment:	Enclosed sprays and lagging, Sealed AIB	Maintenance Type:	N/A
Asbestos Type:	Chrysotile Crocidolite	Frequency of Maintenance Activity	N/A
Material Score:	6	Priority Score:	0

Room Comments:	gutters and drain pipes are plastic soffits are cement
Sample Comments:	N/A
Total Assessment Score:	6
Risk Assessment Category:	Low
Recommendation:	Remove ACM if within the scope of works for refurbishment
