PRELIMINARY SITE REPORT (STRUCTURAL)

Site: Hady Hill Site, Spital, Hady, Chesterfield, S41 0BL

Ref: 23289_CBC-XX-XX-RP-S-1001

Project/Purpose: Development for New Housing Scheme

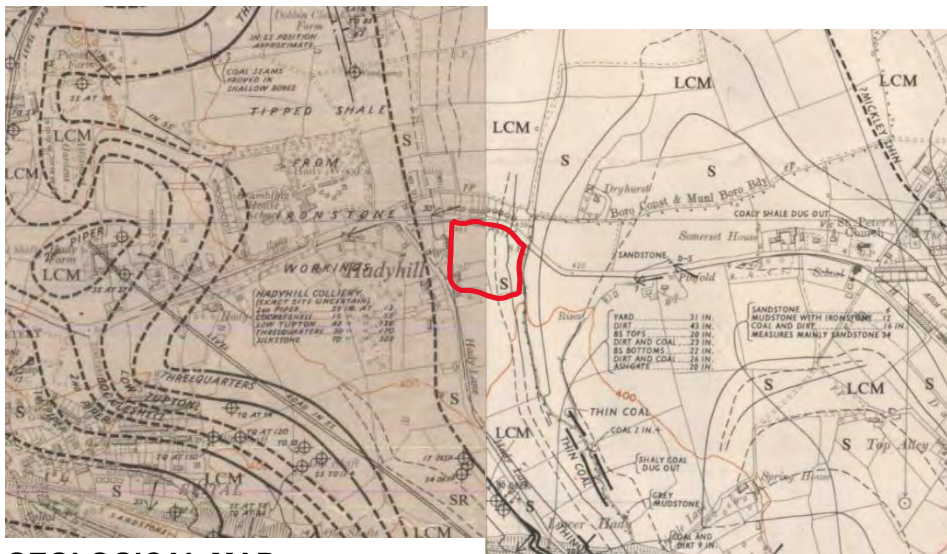
GEOLOGICAL MAP

The site overlays Pennine Lower Coal Measures Formation - Mudstone siltstone and sandstone. Sedimentary bedrock formed between 319 and Site on years ago during the Carboniferous period. A band of sandstone outcrops in the eastern side of the site.

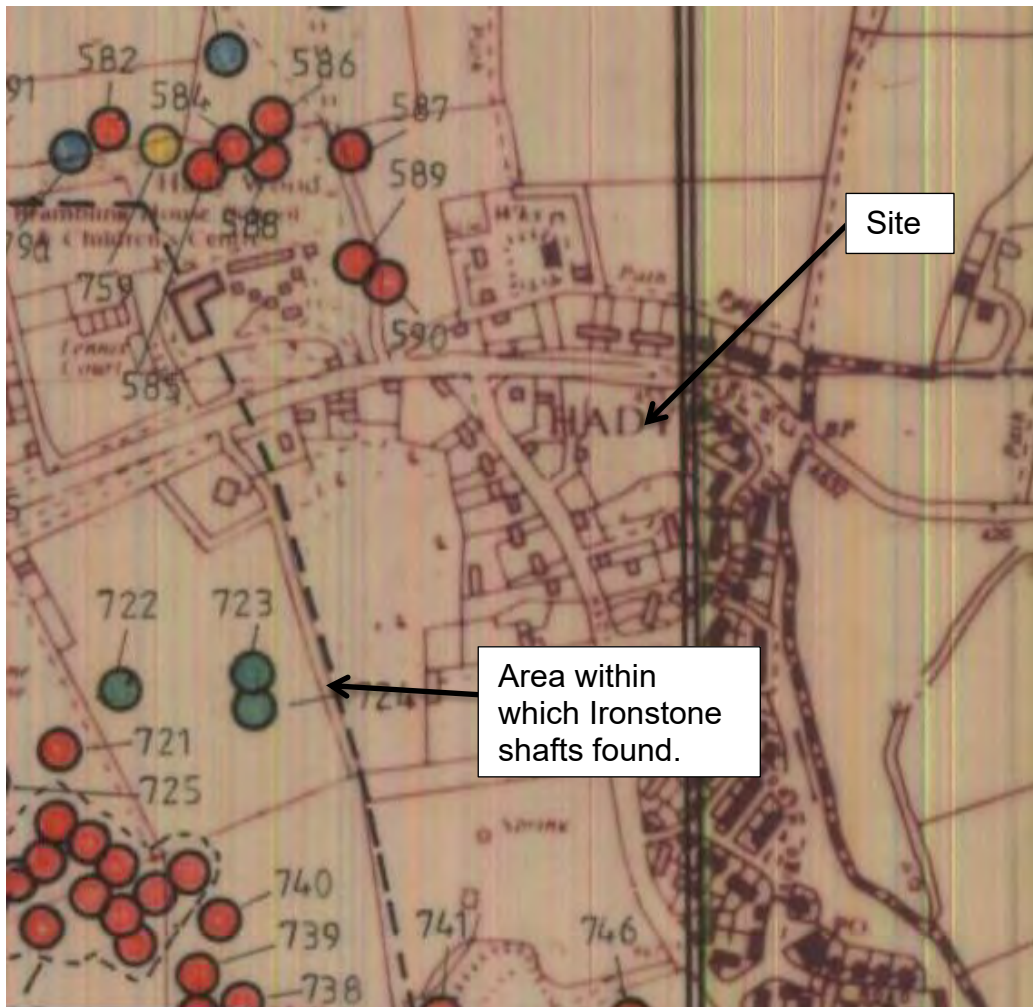
MINING RECORDS (BLUE-IRONSTONE, RED-COAL)

Shafts are known to exist in the locality although the Coal Authority Interactive Map and CBC records do not show any shafts within the site boundaries. However, because the site is in a mining area, the possibility of unknown shafts existing on the site cannot be totally disregarded. The site is identified as being outside an area where a number of Ironstone shafts have been found in the past.

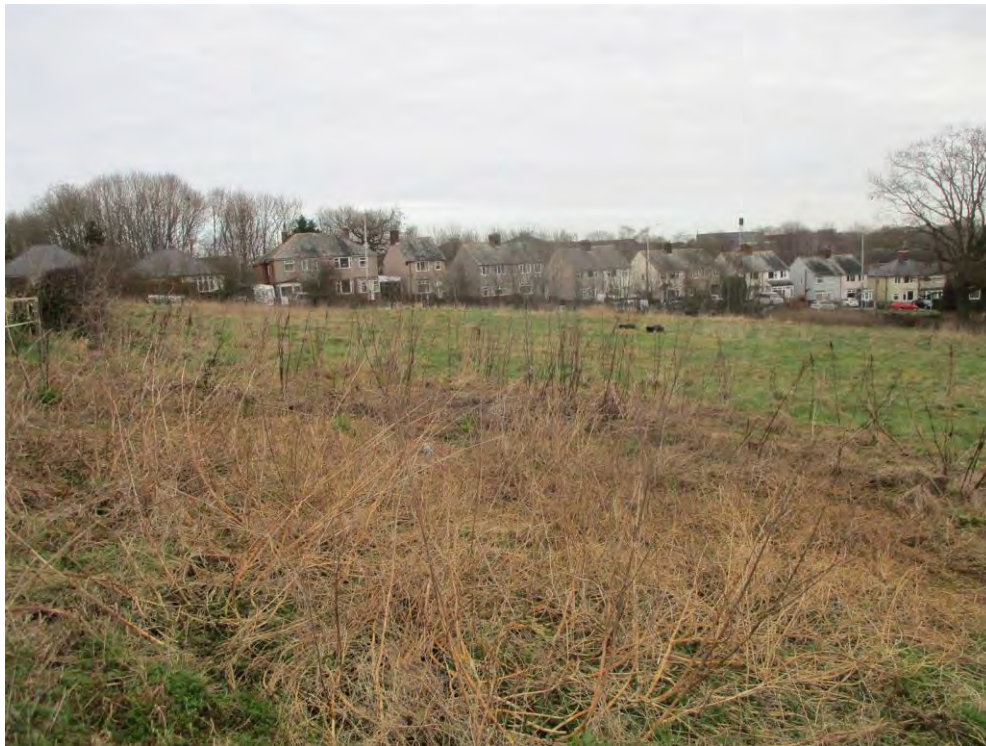
SLOPING SITE LOOKING NORTH-EAST. TYRES VISIBLE.

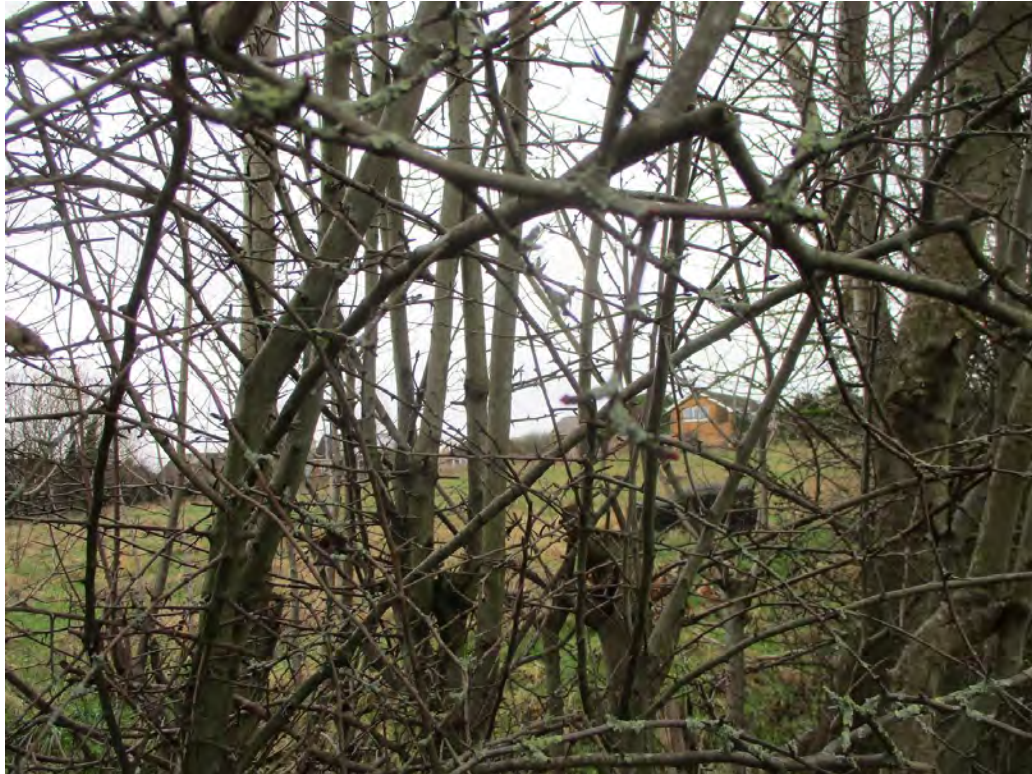
SITE FROM NORTHERN BOUNDARY SHOWING STACKED TYRES

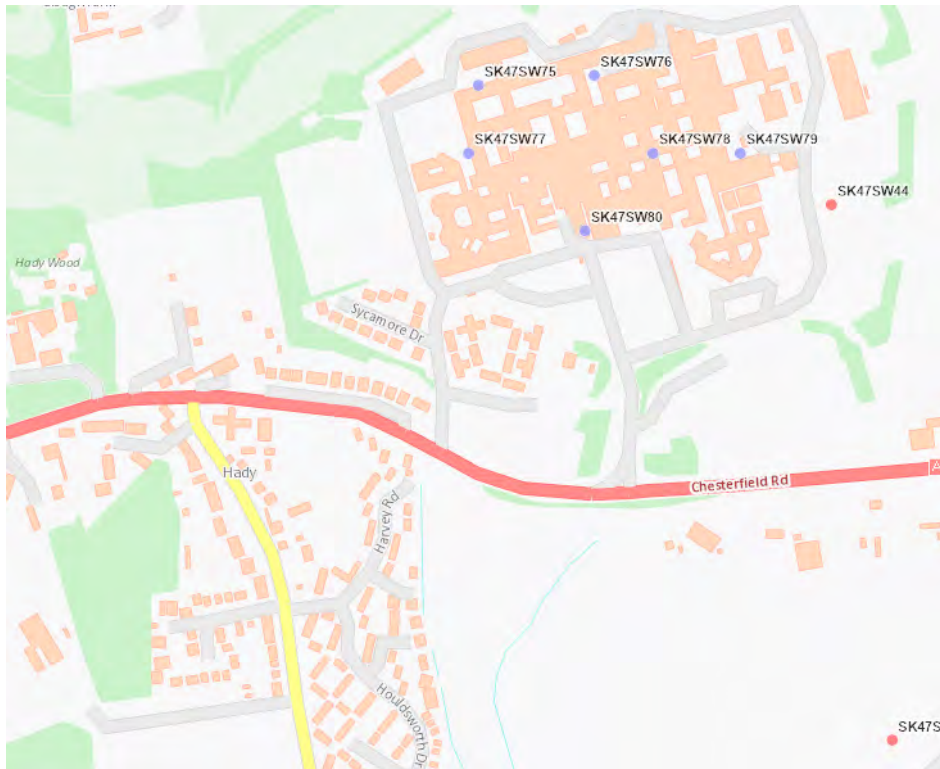
BGS BOREHOLE INFORMATION

There are 8 BGS boreholes known to be in this area 7 in the vicinity of the hospital SK47SW75 to 80 and SK47SW44 and one approximately 600m south-east of the site SK47SW14. These indicate silty clays and sandstones.

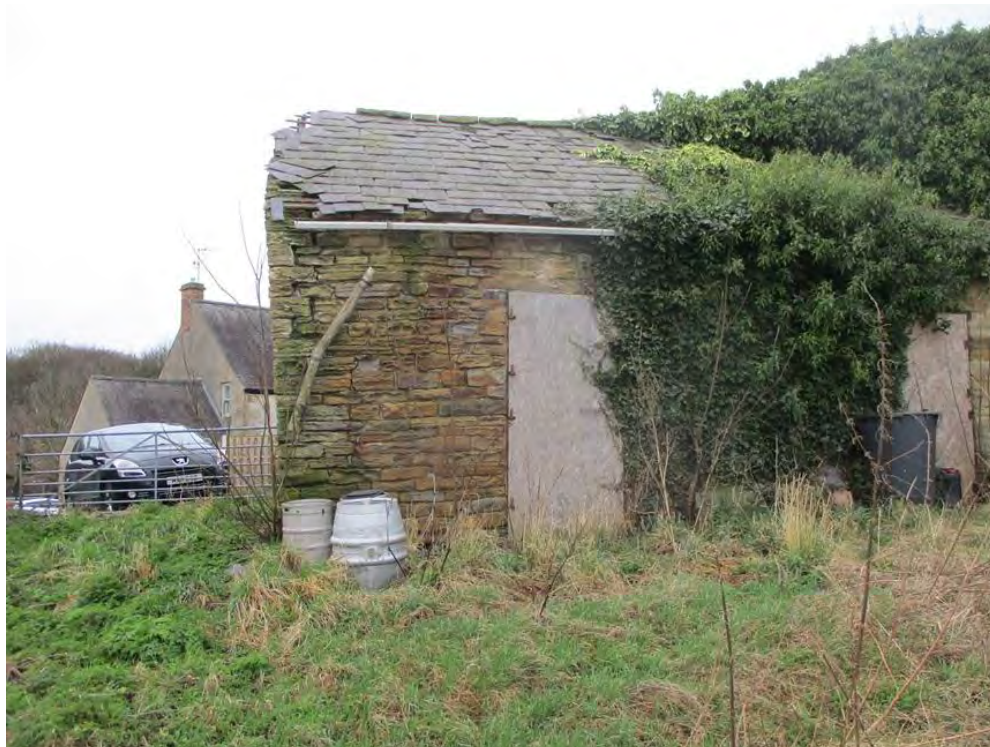
Adjacent the gated access off Hady Hill there is a stone outbuilding. This is in a seriously dilapidated state with the roof collapsing and tiles falling off. The gable wall is also coming away from the front elevation with a large crack that has formed. This building is considered to be in a dangerous condition and should be demolished following an asbestos survey. The broken down-pipes appear to be asbestos cement.

DILAPIDATED BUILDING BY ENTRANCE

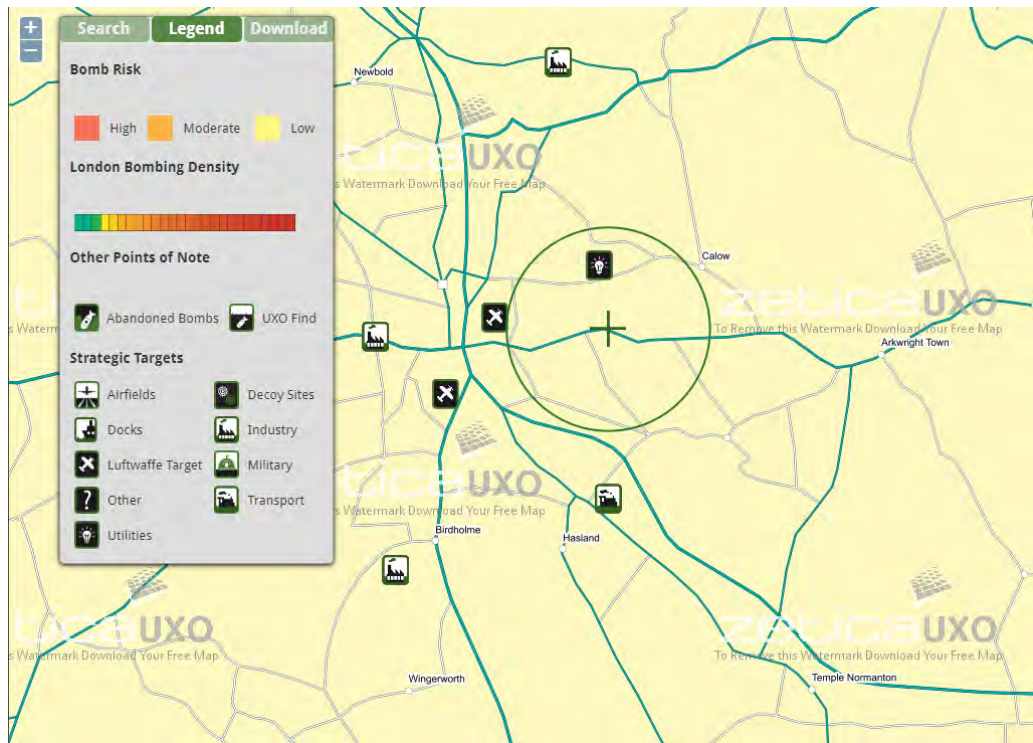
ZETICA UXO MAP

The Staveley iron, coal, and chemical works were Luftwaffe targets. Records indicate that the works were the subject of an unsuccessful raid in August 1942, during which a single Luftwaffe aircraft deployed 16 high explosive items over Staveley and Brimington. Newspaper records indicate that the aircraft also deployed a number of smaller incendiary bombs. A bomb tracing detailing the locations of the High Explosive strikes obtained from the National Archives indicate the strikes were situated some 4.0km north of the proposed site area. It is therefore considered unlikely that they would have encroached the boundaries of this site. The risk of Unexploded Ordnance is therefore considered to be Low which is confirmed by the Zetica map.

Although improbable, there remains a degree of risk as the ground conditions of the site in 1942 (open fields) would not have easily identified an explosive strike.

It is therefore recommended that a Site Specific Unexploded Ordnance Awareness Briefings is provided to all personnel conducting intrusive works prior to the commencement of any works.
