Prepared for
Chesterfield Borough Council

by
Chris Burnett Associates
FEBRUARY 2012

1. Introduction

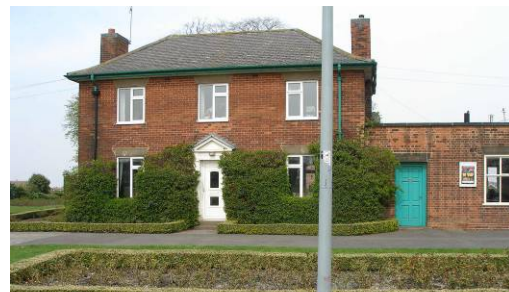
2.2.23 One of the major developments of the mid 1930s was the demolition of the old house and its replacement with a new caretaker’s residence (**Fig 2.2.12**). In 1935 the committee considered the report of the Vice Chairman, Borough Surveyor and Parks Superintendent with regard to the condition of the old mansion and resolved to, “...arrange for the demolition of the Old Mansion and surrounding dilapidated buildings, together with certain old trees, at the earliest possible date...”³⁴ The architect Mr. C. Bond was engaged to prepare plans and estimates for the ‘Caretaker’s Lodge and Refreshment Room’, together with a Store Shed and Greenhouse behind the proposed Lodge. The cost of the proposed works was estimated by the Borough Engineer and Surveyor, Mr. W. S. Wilson, as follows;

Fig 2.2.12 The caretaker’s house and adjacent refreshment room

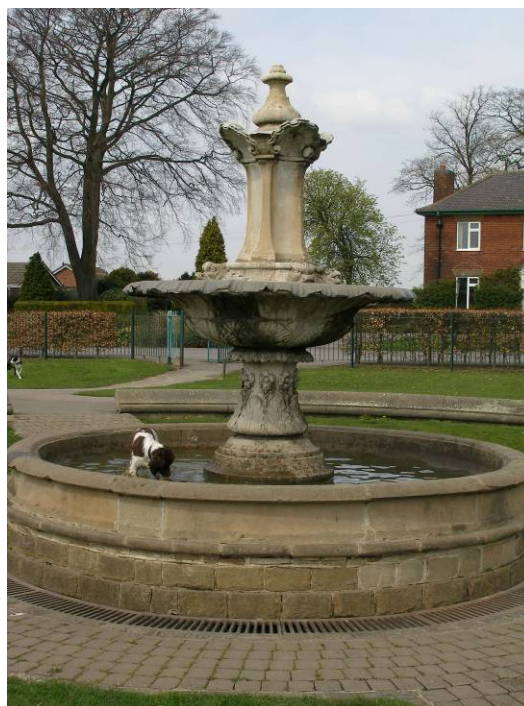
Fig 2.2.15 The Ringwood Fountain donated to the park in 1913 and reinstalled in 2000

- Installation of lighting columns to illuminate drive and surrounds
 - Construction of footpath to provide a link from Hoole Street to Hasland Road.
- 2.2.33 A final and popular development in the park was the re-installation of the water fountain in 2000 (**Fig 2.2.15**). The fountain, first donated by Alderman Markham in 1913, was removed from the park in the 1980s and taken to New Square in the town centre, where it was re-christened the "Peace Fountain". The fountain never really settled in its new location, attracting litter and blowing water onto nearby market stall holders, and was taken back to the park and erected in its original position, although without the water garden that originally surrounded it.⁵³

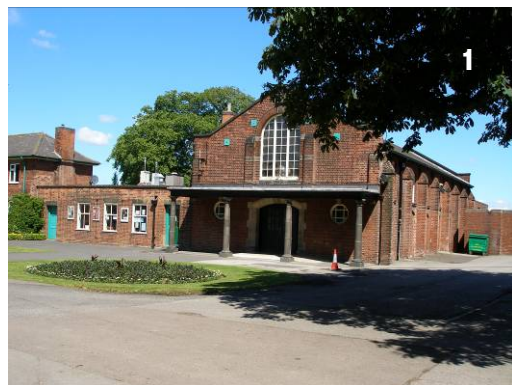
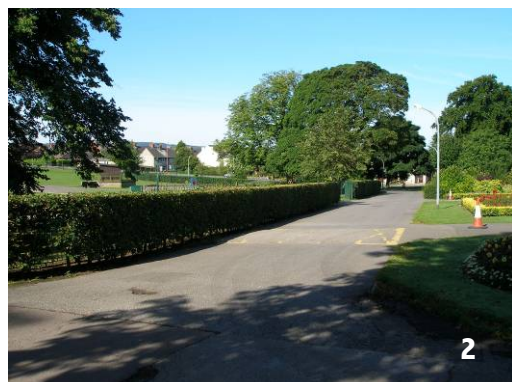
- 2.3.4 This zone has the village hall (photo **1**) and associated dwelling at its centre which is surrounded by a heavily treed but well maintained space. The zone is separated from Zone 3 by a 1.3m high modern, metal railing type fence and beech hedge (photo **2**) which separates it physically and visually from the open park. An entrance drive has recently been created which leads to the Village Hall and car parking area and also to the maintenance yard. A series of mature trees ranging from mature horse chestnuts to limes, ash and beech collectively provide a lightly wooded setting to the village hall and immediate surroundings.

- 2.3.5 The landscape to the west of the hall is in direct contrast to that of its counterpart to the east. The western fringe is comprised of manicured lawns and mature rose beds often surrounded by low box hedges. Many of these beds are looking over mature with roses in need of replacement. A mature shrubbery, again with over-mature shrubs often with gaps nearby, and large mature trees such as beech, horse chestnut and lime lie to the west and north of the hall.

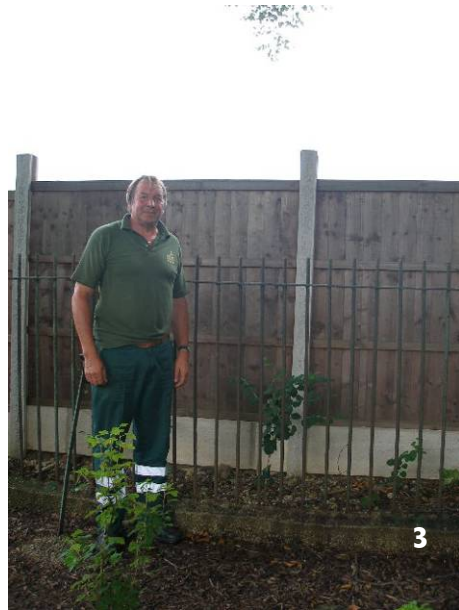
2.3.6 A section of original railing can be found in this shrubbery (photo **3**). The tarmac paths that provide access to this area are in poor condition with a poorly defined edge. A lawned, disused crazy golf course surrounded by a low fence, a 1.8m high close boarded fence and hawthorn hedge, (photo **4**) lies to the north of the hall.

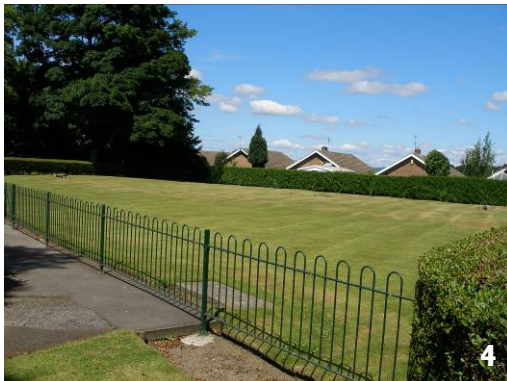
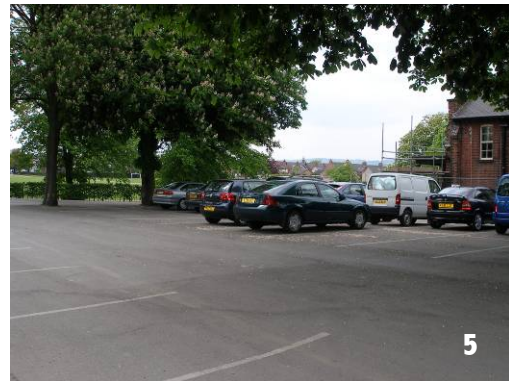
2.3.7 To the east, a rather unattractive poorly designed and large, unevenly surfaced tarmac car park with 42 car parking spaces has become established which wraps around the east of the hall (photo **5**). A disused, brick built toilet block, closed due to vandalism, occupies a position to the north east of the hall and a brick built WW2 air-raid shelter is situated in this zone close to the hall.

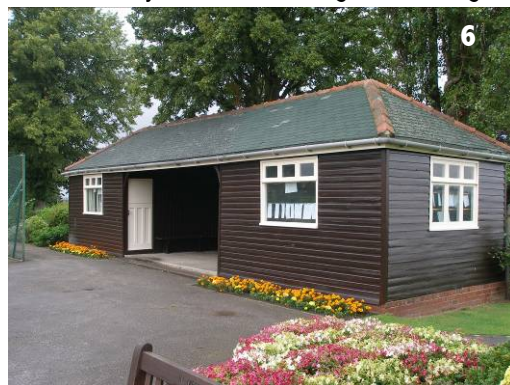
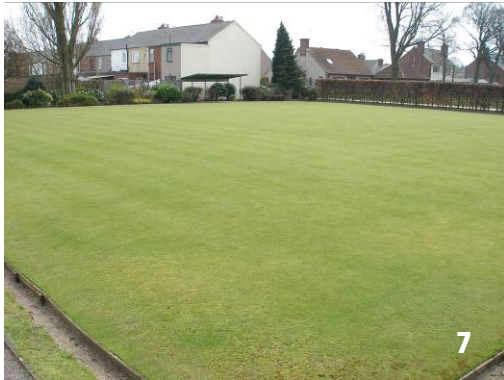
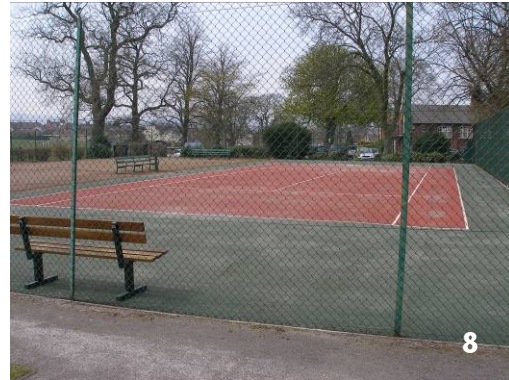
2.3.9 Zone 2 is a small compact part of the park which contains two well maintained bowling greens: one crown and one flat and a tennis court. The crown green is well used and has an accompanying small timber pavilion (photo **6**) and surrounding tarmac path which is in poor condition. On the south side the crown green is flanked by a tall beech hedge and railings (photo **7**). The flat green is enclosed by a tall 2.0m trimmed hawthorn and holly hedge on its north side, an untrimmed holly hedge on the east side and a bank of mature shrubs to the south. The tennis courts consist of one working tarmac court with a surface that needs refurbishment and one disused tennis court. The associated back netting has recently been replaced and is in largely good order, (photo **8**)

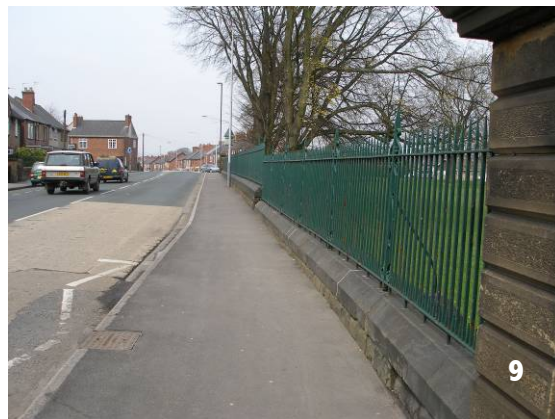
- 2.3.11 The largest zone in the park is the open park zone. This is separated from Zones 1 and 2 by a mature beech hedge and metal vertical bar railing fence. A zone of well cut grass which supports football pitches, the cricket square and play areas as well as informal recreational activity such as dog walking. A number of paths provide all weather access across and around this zone. It is defined on all sides by metal railings the most historic of which occurs along Hasland road in the form of ornate cast iron railings on a sandstone retaining wall (photo **9**). The vertical metal railings that define the western boundary however, were installed on a temporary basis some years ago and are now uneven and in generally poor repair.

- 2.3.12 The main pedestrian entrance off Hasland Road is looking tired and unwelcoming (photo **10**). The gates have not been painted recently and the pillars exhibit the effects of atmospheric pollution. One pillar has been damaged and the tarmac apron in front of the gates is also in a poor state with patch repair of the tarmac in evidence.

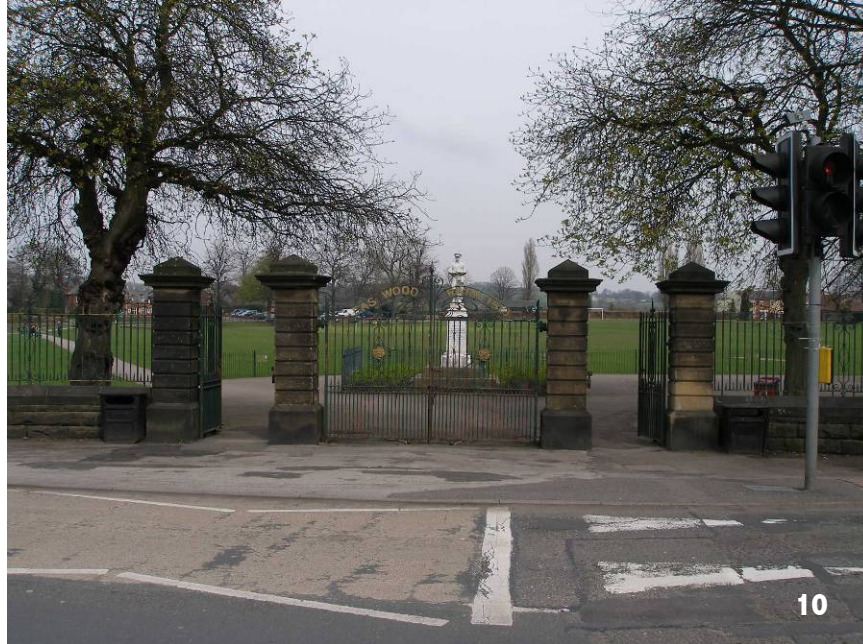
- 2.3.13 There are two play areas which are in separate areas of the park. The infant play area, (photo **11**) is in a low area in the north- west corner of this zone. It is surrounded by a wooden low picket fence and many of the items of play equipment are now well used and past their best. This area suffers from poor drainage.

- 2.3.14 A junior play area is located in the opposite corner of the park (photo **12**) and has a few limited items of equipment much of which are again old and past their best. The area is fenced off with a 1.2m high metal bow topped park fence.

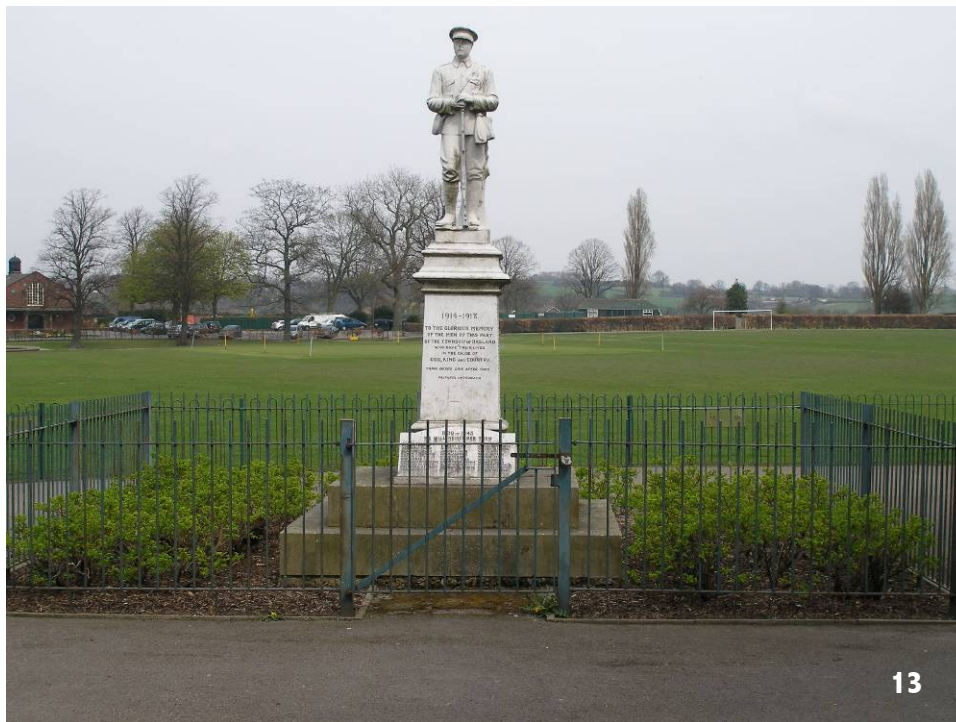
- 2.3.20 The war memorial stands at the main entrance to the park (photo **13**). Although the stone statue and the surrounding metal railings are in good condition, the railings and internal planting appear too close to the memorial.
- 2.3.21 A limited number of seats exist in the park, which are in reasonable condition but of varying styles. Most have metal ends, arms and timber slats. The seats along the eastern perimeter have been the focus of antisocial behaviour in the past.

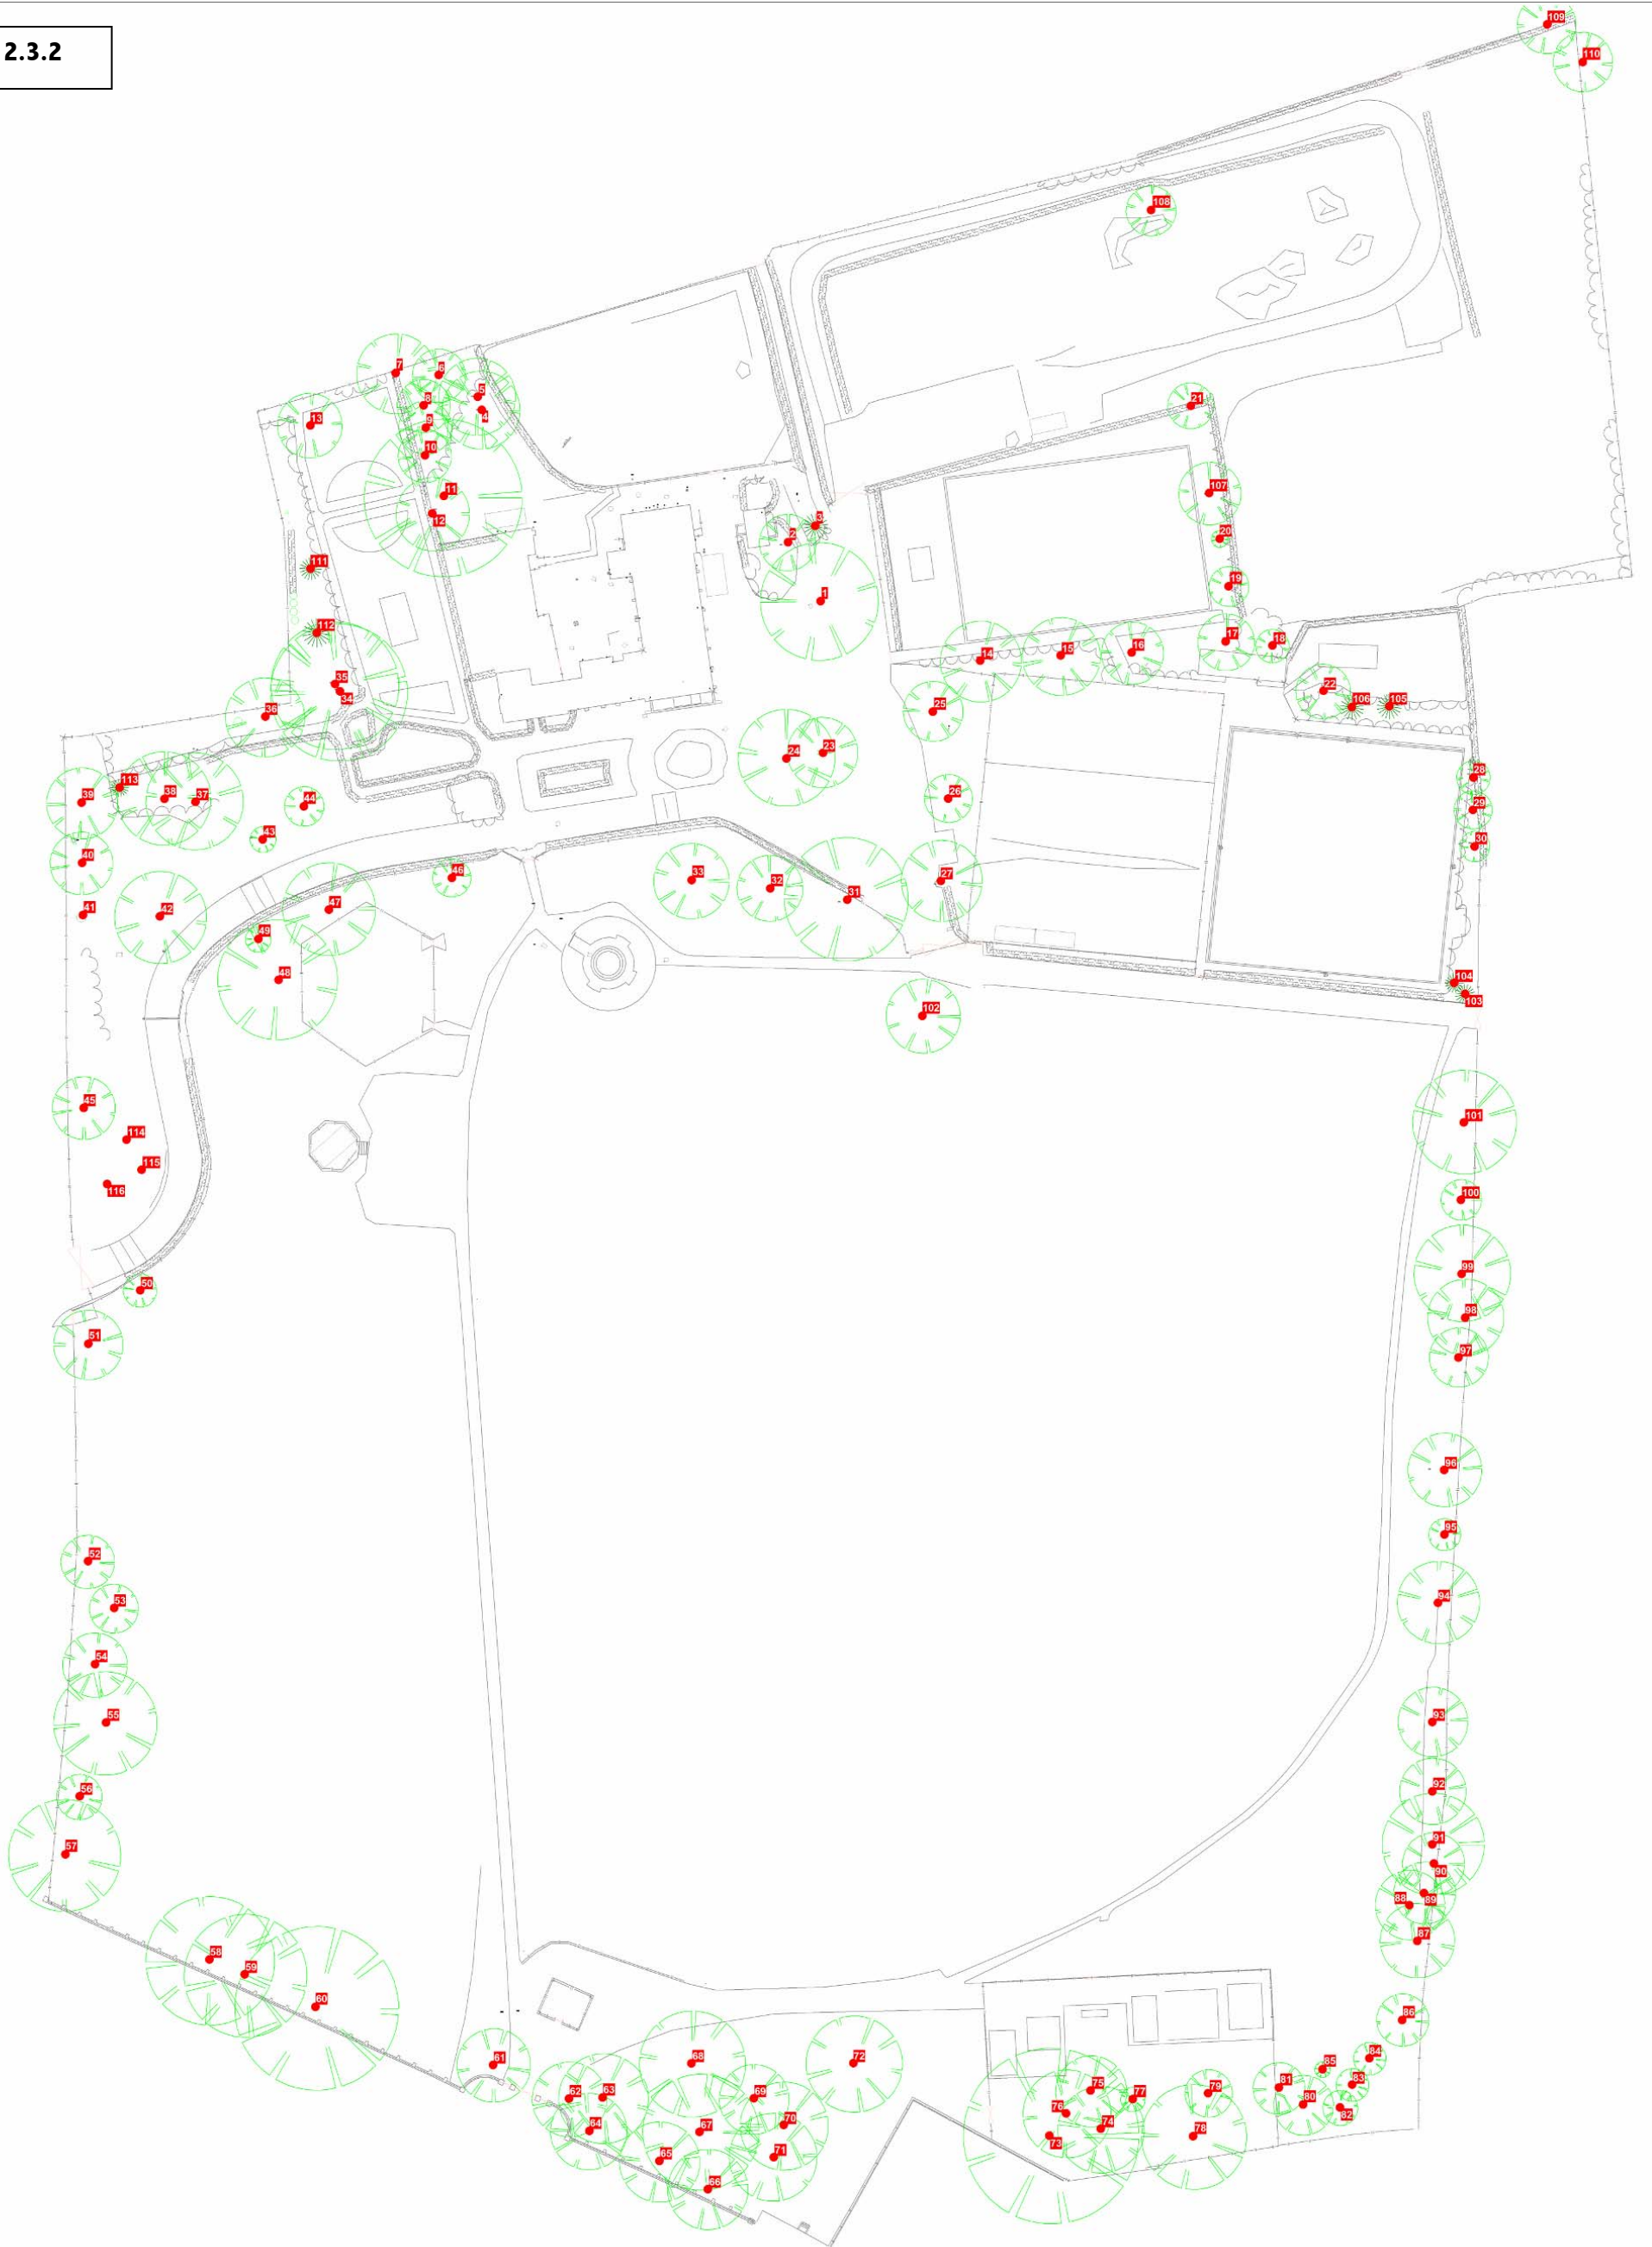
Fig 2.3.2

- 2.3.23 The results of the tree survey are listed below. The majority of the trees within the park appear to be in reasonable health at the time of survey although there are several large mature specimens of beech which are nearing the end of their lifespan and maybe prone to structural failure without warning. It may therefore be prudent to undertake a detailed arboricultural assessment of these trees by a fully qualified arboriculturalist. Several horse chestnut trees: nos. 48 and 23 are dying and should be felled before limb drop occurs. The two wych elms tree nos. 65 and 66 on the Hasland road perimeter that are suffering from Dutch elm disease should also be felled. The remainder of the trees in the park, with the exception of a young wych elm which is in the centre of the proposed play area (see section 7) should be retained.

Eastwood Park: Tree Survey

No	Species	Girth	Condition	Age	Notes
1	Horse Chestnut	900	poor	mature	Some rot in upper trunk monitor
2	Lime	1100	good	mature	
3	Holly	200	good	semi-mature	
4	Sycamore	1000	reasonable	mature	Poor crown
5	Lime	750	good	mature	
6	Yew	500	good	semi-mature	
7	Sycamore	900	good	semi-mature	
8	Yew	100	good	young	
9	Yew	200	good	young	
10	Cherry	300	good	young	
11	Lime	1100	good	mature	
12	Lime	600	good	mature	
13	Horse Chestnut	900	good	mature	
14	Lime	700	good	semi-mature	
15	Lime	800	good	semi-mature	
16	Lime	500	good	semi-mature	
17	Lime	500	good	semi-mature	
18	Lombardi Poplar	600	good	semi-mature	
19	Maple	200	good	young	
20	Maple	400	good	young	
21	Acer pseudoplatanus 'Crimson King'	300	poor	young	Dying back in crown
22	Cherry	400	good	mature	
23	Horse Chestnut	500	poor	semi-mature	Poor condition rot evident
24	Horse Chestnut	700	poor	semi-mature	Poor condition fell rot evident
25	Ash	900	good	mature	
26	Elm	300	good	young

27	Ash	1500	good	mature	
28	Lombardi Poplar	900	good	semi-mature	
29	Cherry	400	good	mature	
30	Lombardi Poplar	900	good	semi-mature	
31	Oak(Turkey)	800	reasonable	semi-mature	
32	Lime	900	good	mature	
33	Lime	900	good	mature	
34	Beech	1100	good	mature	Full inspection recommended
35	Beech	1100	good	mature	Full inspection recommended
36	Beech	800	good	semi-mature	
37	Beech	700	good	semi-mature	
38	Beech	600	good	semi-mature	
39	Sycamore	500	good	semi-mature	
40	Cherry	300	good	young	
41	Holm Oak	150	good	young	
42	Sycamore	600	good	semi-mature	
43	Whitebeam	150	good	young	
44	Sweet Chestnut	200	good	young	
45	Cherry	500	poor	mature	
46	Lime	300	good	young

47	Sycamore	1000	poor	mature	Poor crown
48	Horse Chestnut	900	poor	mature	Poor condition , recent tree surgery
49	Maple	150	good	young	
50	Beech	150	good	young	
51	Cherry	300	reasonable	young	
52	Beech	200	reasonable	young	
53	Alder	300	poor	mature	Hollow trunk
54	Sycamore	150	good	young	
55	Lime	600	good	mature	
56	Oak (Pin)	200	good	young	
57	Lime	900	good	mature	
58	Wych elm	900	good	mature	
59	Wych elm	900	good	mature	
60	Wych elm	900	good	mature	
61	Horse Chestnut	800	poor	mature	
62	Horse Chestnut	800	poor	mature	
63	Lime	400	reasonable	semi-mature	
64	-	-	-	-	felled
65	Ash	800	good	semi-mature	Diseased : fell
66	Cherry	800	good	semi-mature	Diseased : fell
67	Sycamore	700	reasonable	semi-mature	
68	Cherry	400	good	semi-mature	
69	Lime	500	good	semi-mature	
70	Lime	400	good	semi-mature	
71	Sycamore	600	good	mature	
72	Cherry	500	good	semi-mature	
73	Beech	1100	good	mature	
74	Beech	1000	good	semi-mature	
75	Elm	700	good	semi-mature

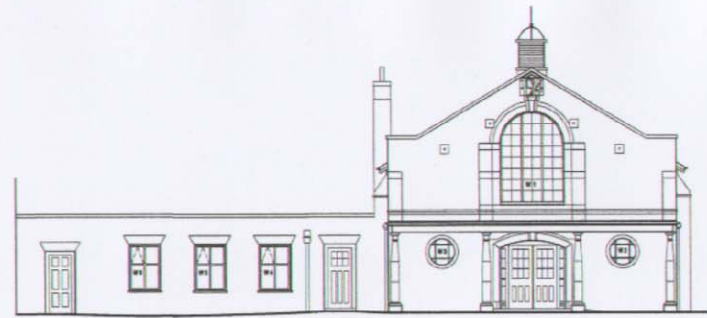
SOUTH ELEVATION

Village Hall elevations

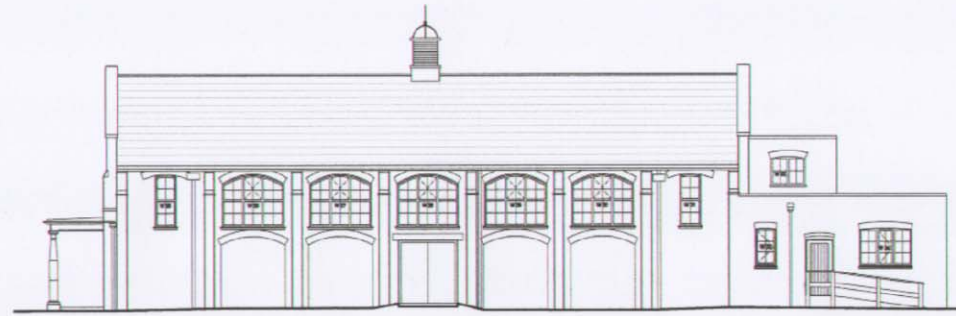
NORTH ELEVATION

Division of Regeneration, Design Services, Architectural Consultancy, Team Hall, Chesham, Dorset, BA9 5JA. Tel: 01258 24026 Fax: 01258 24026		
CONTRACT EASTWOOD PARK RENOVATION		
DRAWING TITLE HASLAND VILLAGE HALL EXISTING ELEVATIONS		
DRAWN: JH	SCALE: 1:100	
CHECKED:	DRAWING NO: 730/1/05	REV:
DATE: FEB 2008

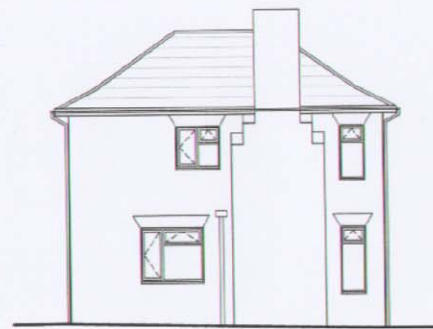
EXISTING SIDE ELEVATION (WEST)

Caretaker's Lodge

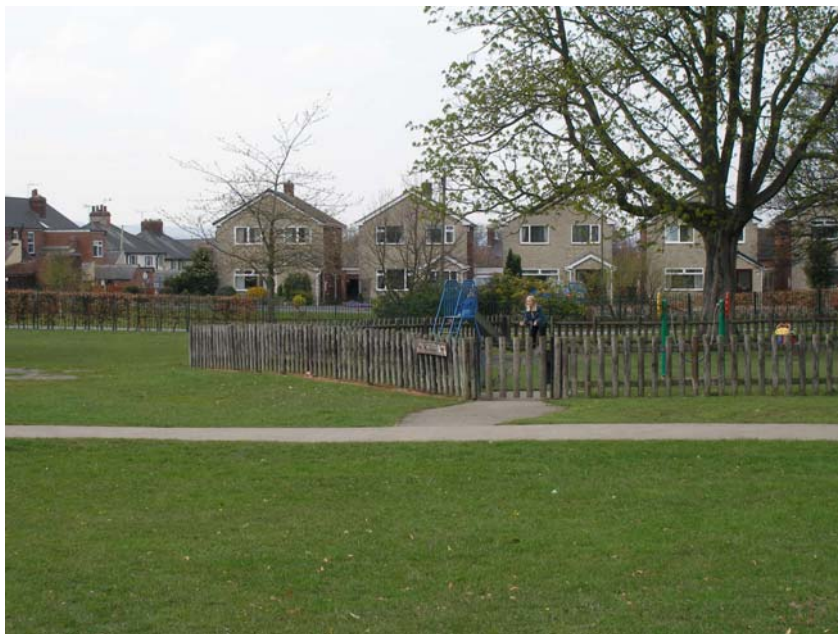
Fig 2.4.5 The former stream running from the fountain towards Eastwood Park Drive has now been filled in but would have previously run through the toddlers play area

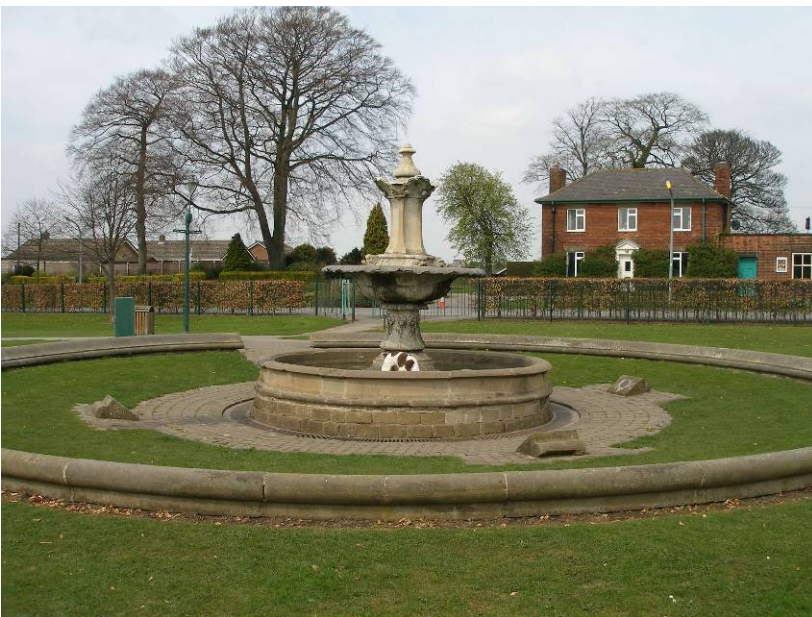
Fig 2.4.7 The water fountain donated by Alderman Markham in its original glory above and re-instated in 2000 without the water garden features or water jets

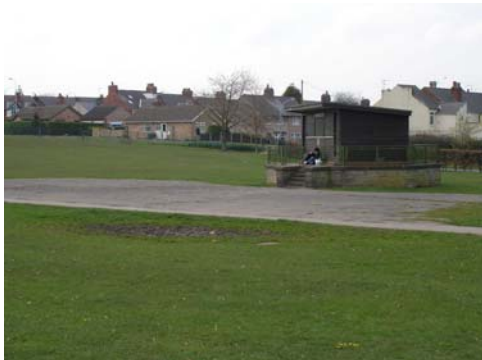
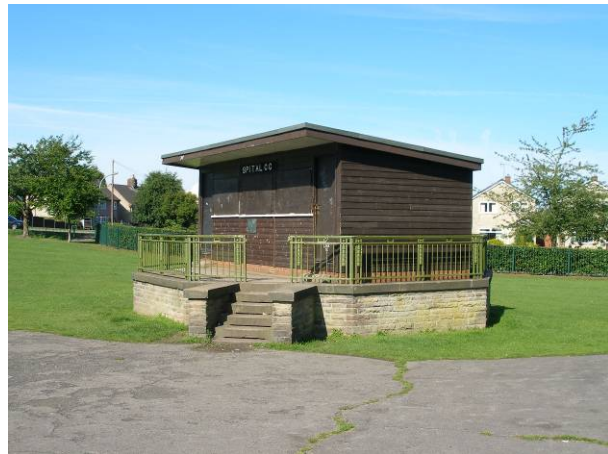
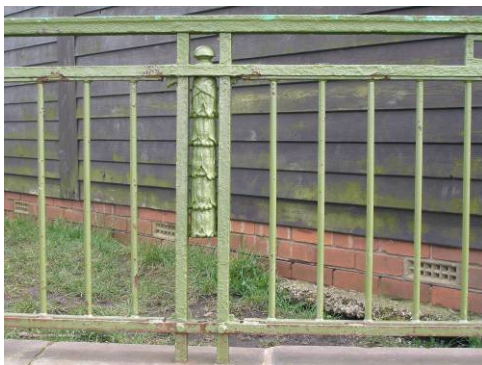
- 2.4.22 In 1946 the enclosed area in front of the bandstand increased and re-surfaced in tarmac due to its poor condition. By 1958 the superstructure was in a poor condition and tenders were invited to demolish it. The base remained and in 1967 the present cricket 'pavilion' was built on top. The bandstand / cricket shed is shown in its present form below.

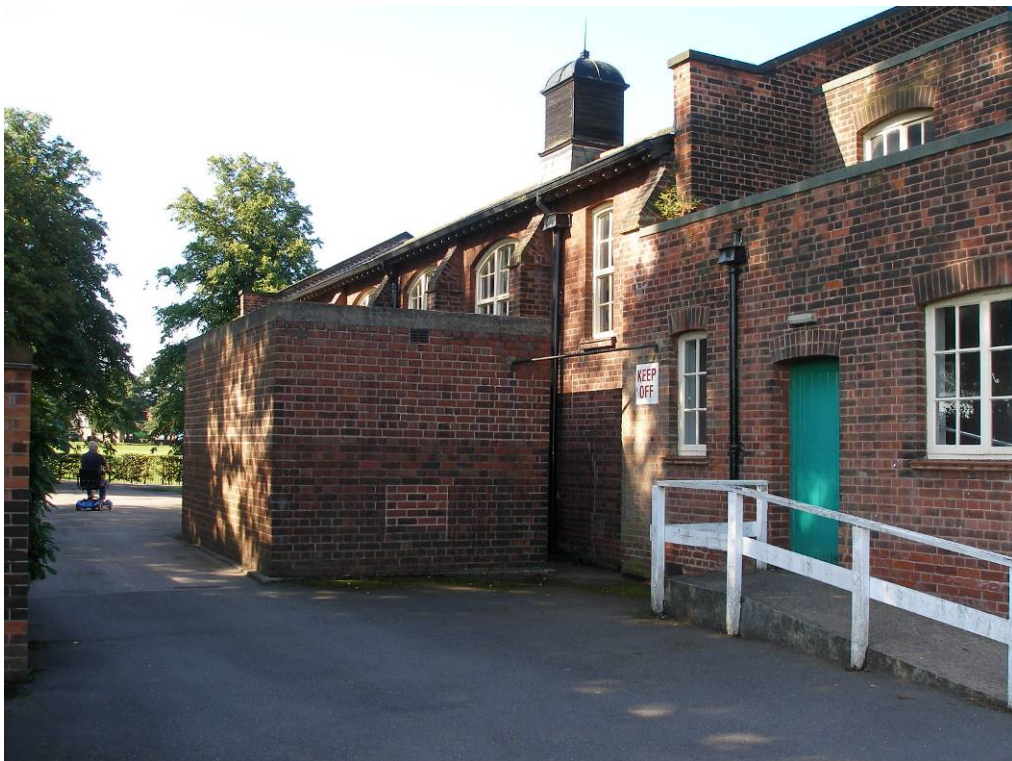
Side elevation showing ramped access to the rear and the brick built air raid shelter which interrupts the rhythm of the Village Hall facade

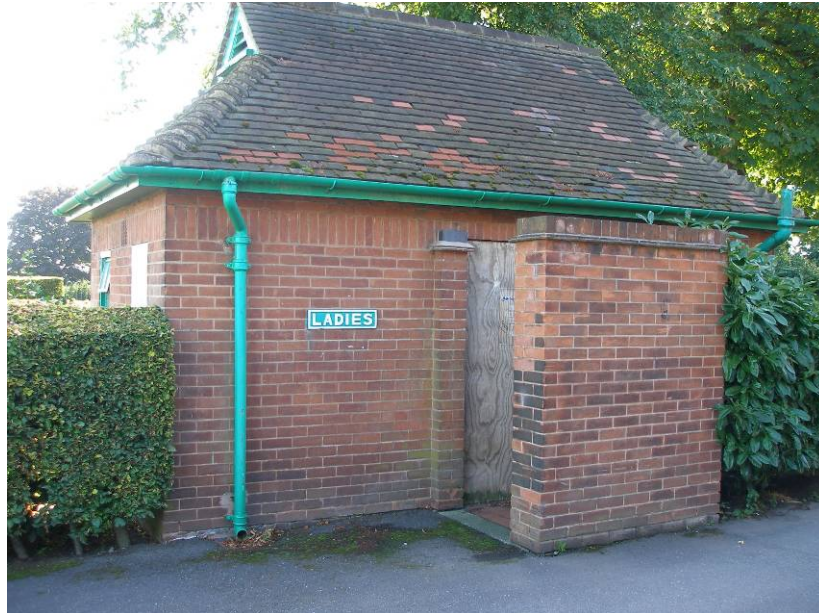
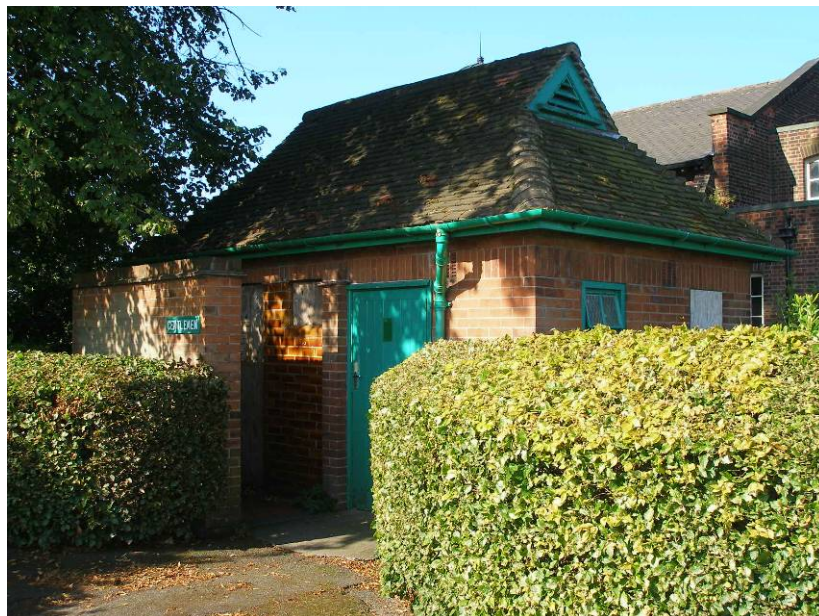
7. Village Hall Outside Toilets

- 2.4.26 The public conveniences adjacent to the Village Hall were built in 1935 by Messrs, Chas. Vallance & Son of Mansfield, at a cost of £330 – 7 – 10d. The toilets are brick built with a hipped, 'rosemary' style slate roof and are now closed being used occasionally by the bowling club. The building retains local architectural character.

- 5.3.5 The outside toilet forming a detached block is largely screened by large shrubs and has been locked off for a number of years due to vandalism. The building itself has local character and is structurally sound.
- 5.3.6 The bowling pavilion requires constant maintenance and is used as an unofficial youth shelter out of hours and is prone to misuse. On one occasion an attempt was made to set it on fire.
- 5.3.7 Finally, the water fountain, reintroduced in 2000 is in reasonable condition but can often block up and dogs in the water can be a particular problem.

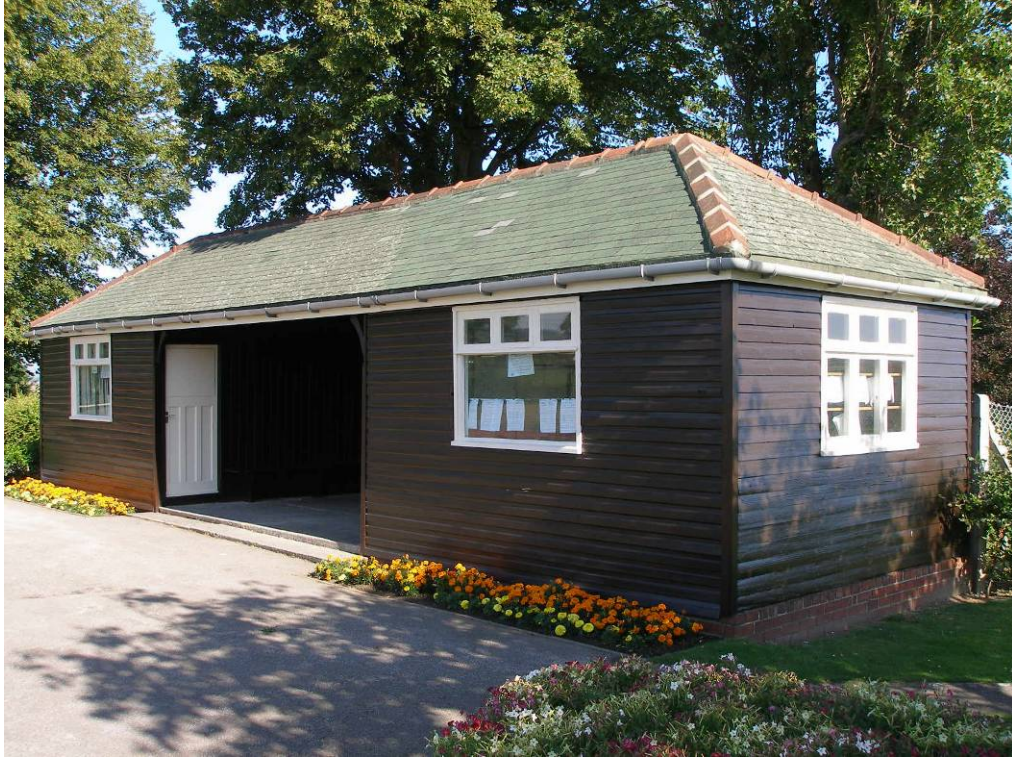
8. Bowling Green pavilion

2.4.27 A wooden structure built in 1934 by Mr. F. Beardlow at a cost of £186 – 10 – 0d. It comprises two square rooms at either end with a covered shelter area in the centre.

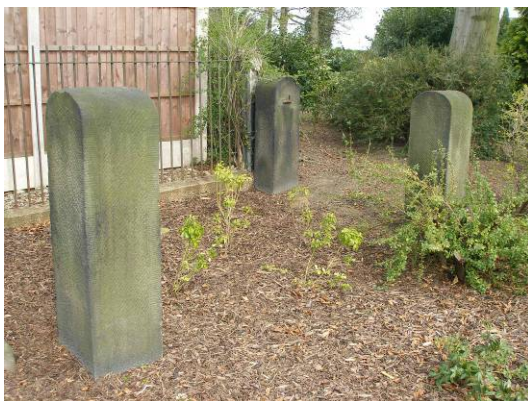
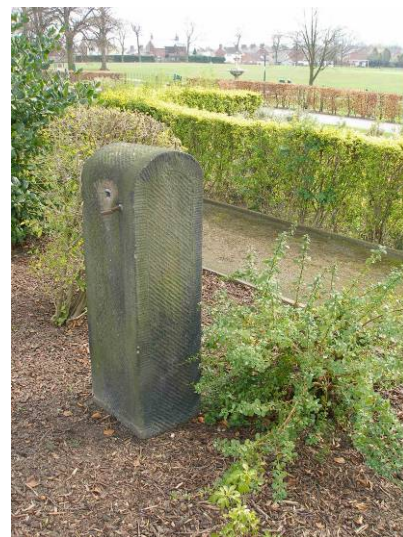
9. Original Gate Posts

2.4.28 These stone pillars remain from the original back entrance to Hasland House from the adjacent fields as shown on early maps.

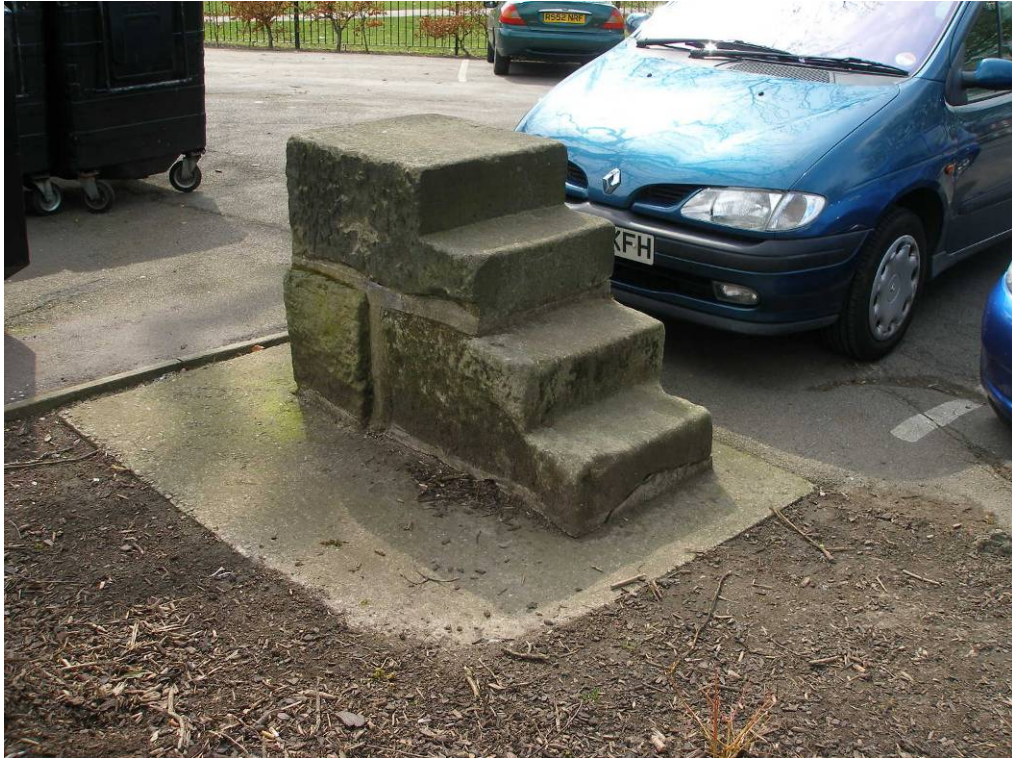
10. Tram Car Steps

- 2.4.29 This set of stone steps once gave access to an old tram car body which was brought into the park to provide a covered space for village elders to play cards and dominoes. The tram car was introduced in 1927 but it is not known when it was removed. Clearly the steps were more difficult to dismantle and remain on the edge of the existing car park as a park curio. The stone used for the steps is old suggesting it may have been part of an old mounting block associated with the outbuildings of the former Hasland House and later adapted as access for the tram car.

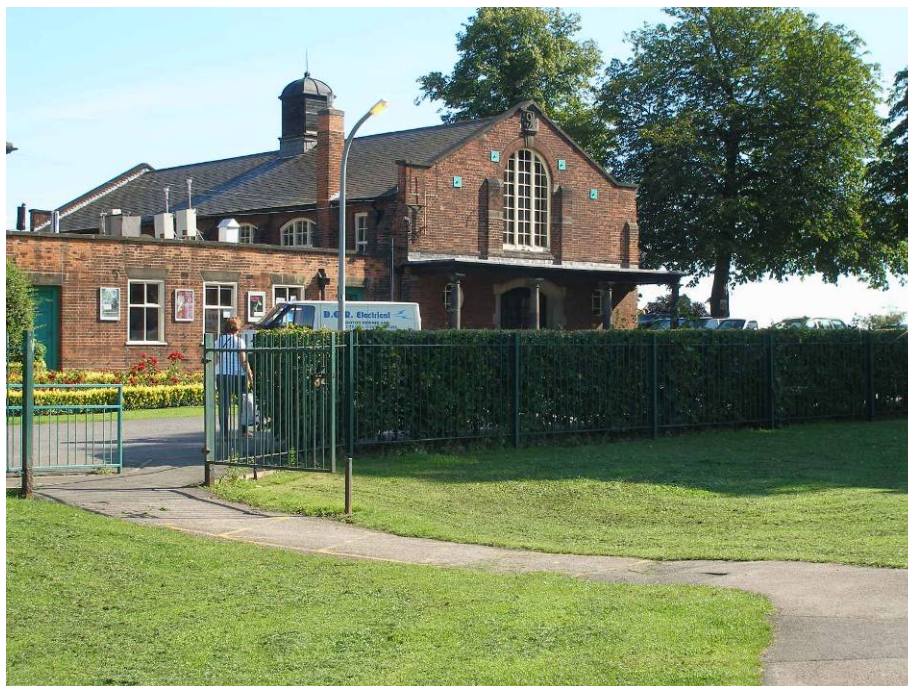
5.2.1 The physical setting of the former house site and Village Hall and its previously open relationship with the parkland is now compromised by piecemeal developments that have accrued over the years. In particular, the expansive area of tarmac that has developed around Village Hall is unsympathetic and the new 'access road' together with the beech hedge and railings introduced in the 1990s compromises the historic view of the house and hall. Negative visual impact is also produced by the neighbouring sub-regional maintenance yard to the rear of the Village Hall, particularly the impact of the overgrown Leyland cypress hedge.

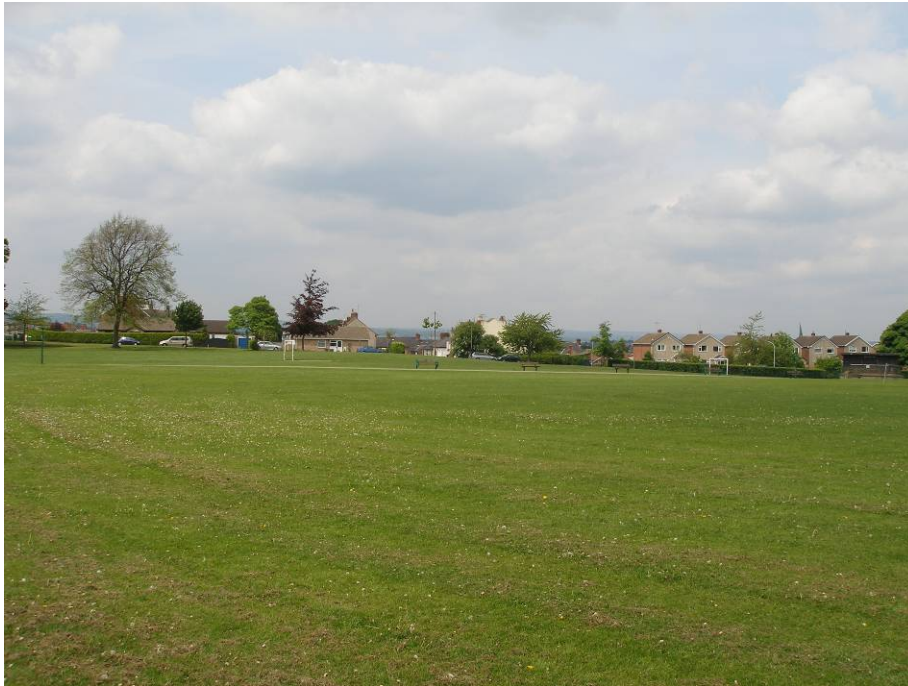
5.2.2 There has been a loss of historic fabric including the main drive through the parkland (which made way for the upgrading of the cricket pitch and football pitch in the late 1950s). There has also been a corresponding loss of mature avenue and parkland trees due to conflict with the cricket and football pitches, as reported by the Council Committee minutes over a number of years. The resulting openness of the park can be particularly bleak in the winter. Some of

the remaining mature trees, particularly the horse chestnuts are showing signs of die-back and are in poor condition.

There has also been a gradual removal of mature park trees over the years and a number of remaining trees in the core area are in a poor condition.

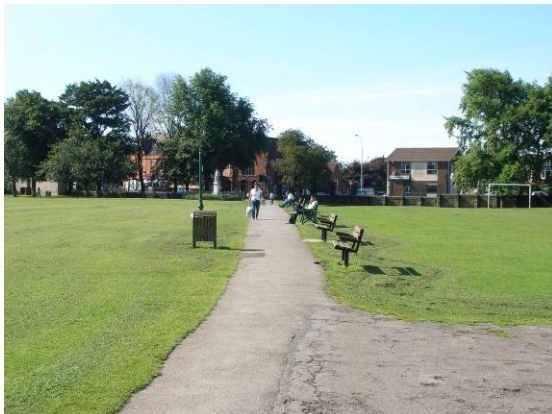
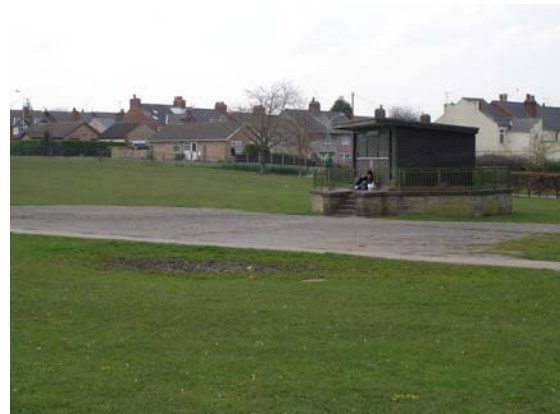
5.2.3 A number of tarmac paths are in poor condition particularly:

- The main path from the entrance gates to the Village Hall which cuts through the middle of the park and is very uneven – it is also too narrow for a main thoroughfare leading to eroded edges
- The tarmac ‘forecourt’ to the bandstand base / makeshift cricket ‘pavilion’
- The path network in the formal garden area and around the bowling green.

Footpath surfaces have degraded with time and the present network is inadequate to cope with existing use.

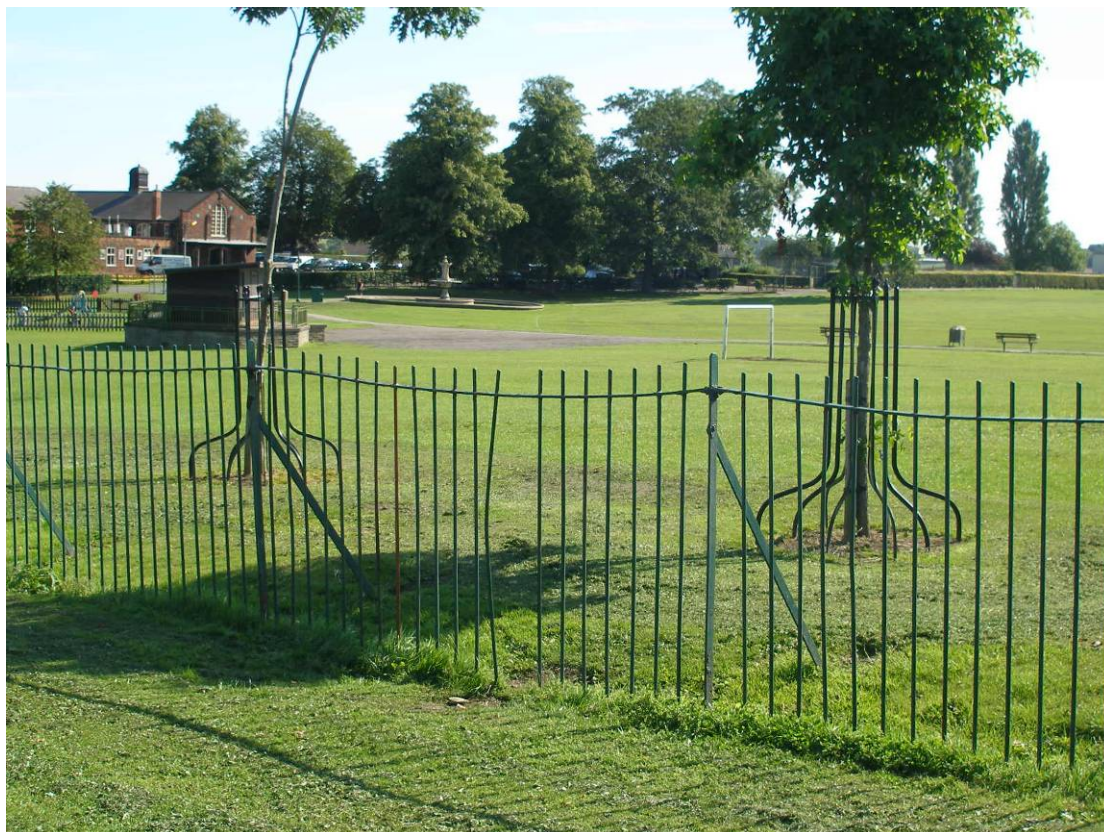
5.2.4 The Park boundary railings are also in poor condition and lack uniformity due to a number of different sorts being introduced over the years. In particular, the western boundary railings which were introduced on a temporary basis are in very poor state and the main railings along Hasland road need restoring and repainting.

The present main entrance gates and wall fronting Hasland Road, one of the main heritage features of the park, are structurally sound but require cleaning and painting. Elsewhere, boundary railings are in poor condition and often inadequate and need upgrading.

- 21 Main entrance gates cleaned and restored. Main railings restored and repainted.
- 22 New seats and litter bins.
- 23 Railings replaced along Eastwood Park Drive.

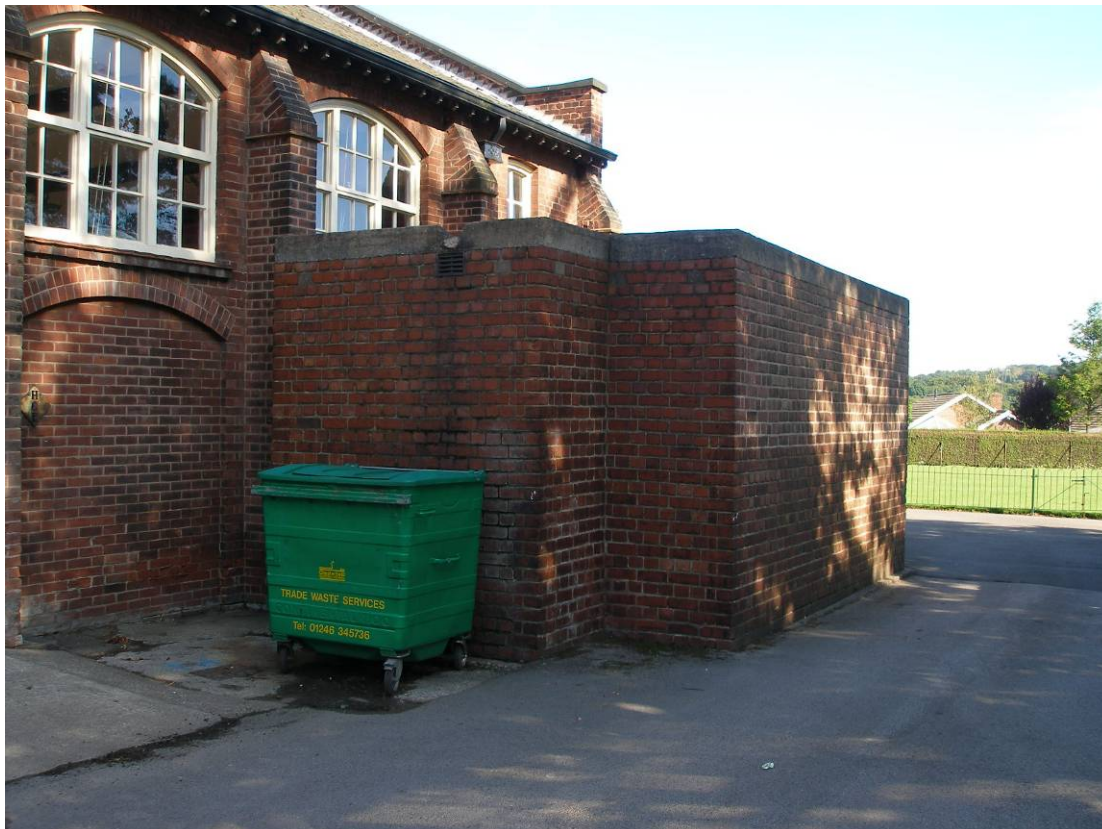
- 5.3.4 The main body of the Village Hall is linked to the Caretaker's Lodge by a single storey utility block built as a 'refreshment room' in 1935. This uninspiring link building is also marred by a number of structures monitoring air quality which have been placed on the flat roof and can clearly be seen from the park. Immediately outside of the Village Hall on the eastern side is a redundant and unsightly air raid shelter, whose close proximity compromises its setting. It also acts as a unsociable hiding place at night.

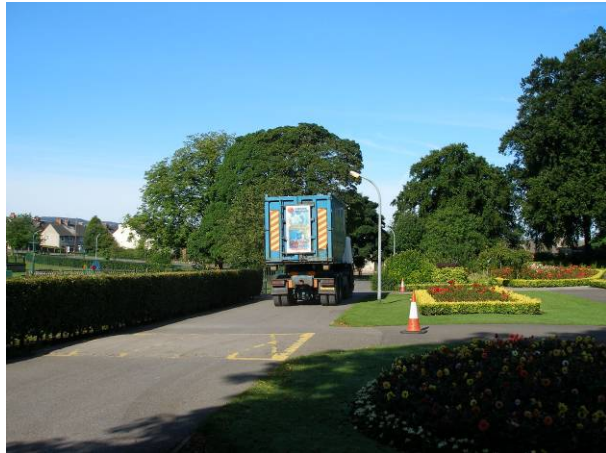
5.5.1 There is a conflict between vehicular traffic and pedestrian movement between the park and the hall. This disruption is caused by constant traffic travelling along the access road in front of Village Hall both to the car park and the sub-regional maintenance depot. In effect this splits the park in two and is a constant danger, particularly to children walking, often running to and from the Village Hall.

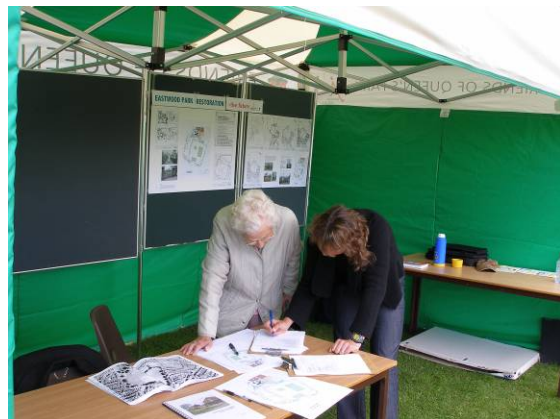
5.7.2 Park users lamented the lack of seating, litter and dog bins in general and also bemoaned the lack of public toilets and café within the park itself. The local community appreciates the open space and facilities the park provides but residents who live next to the park are concerned over perceived nuisances in the future.
