Prepared for
Chesterfield Borough Council

by
Chris Burnett Associates
FEBRUARY 2012

1. Introduction

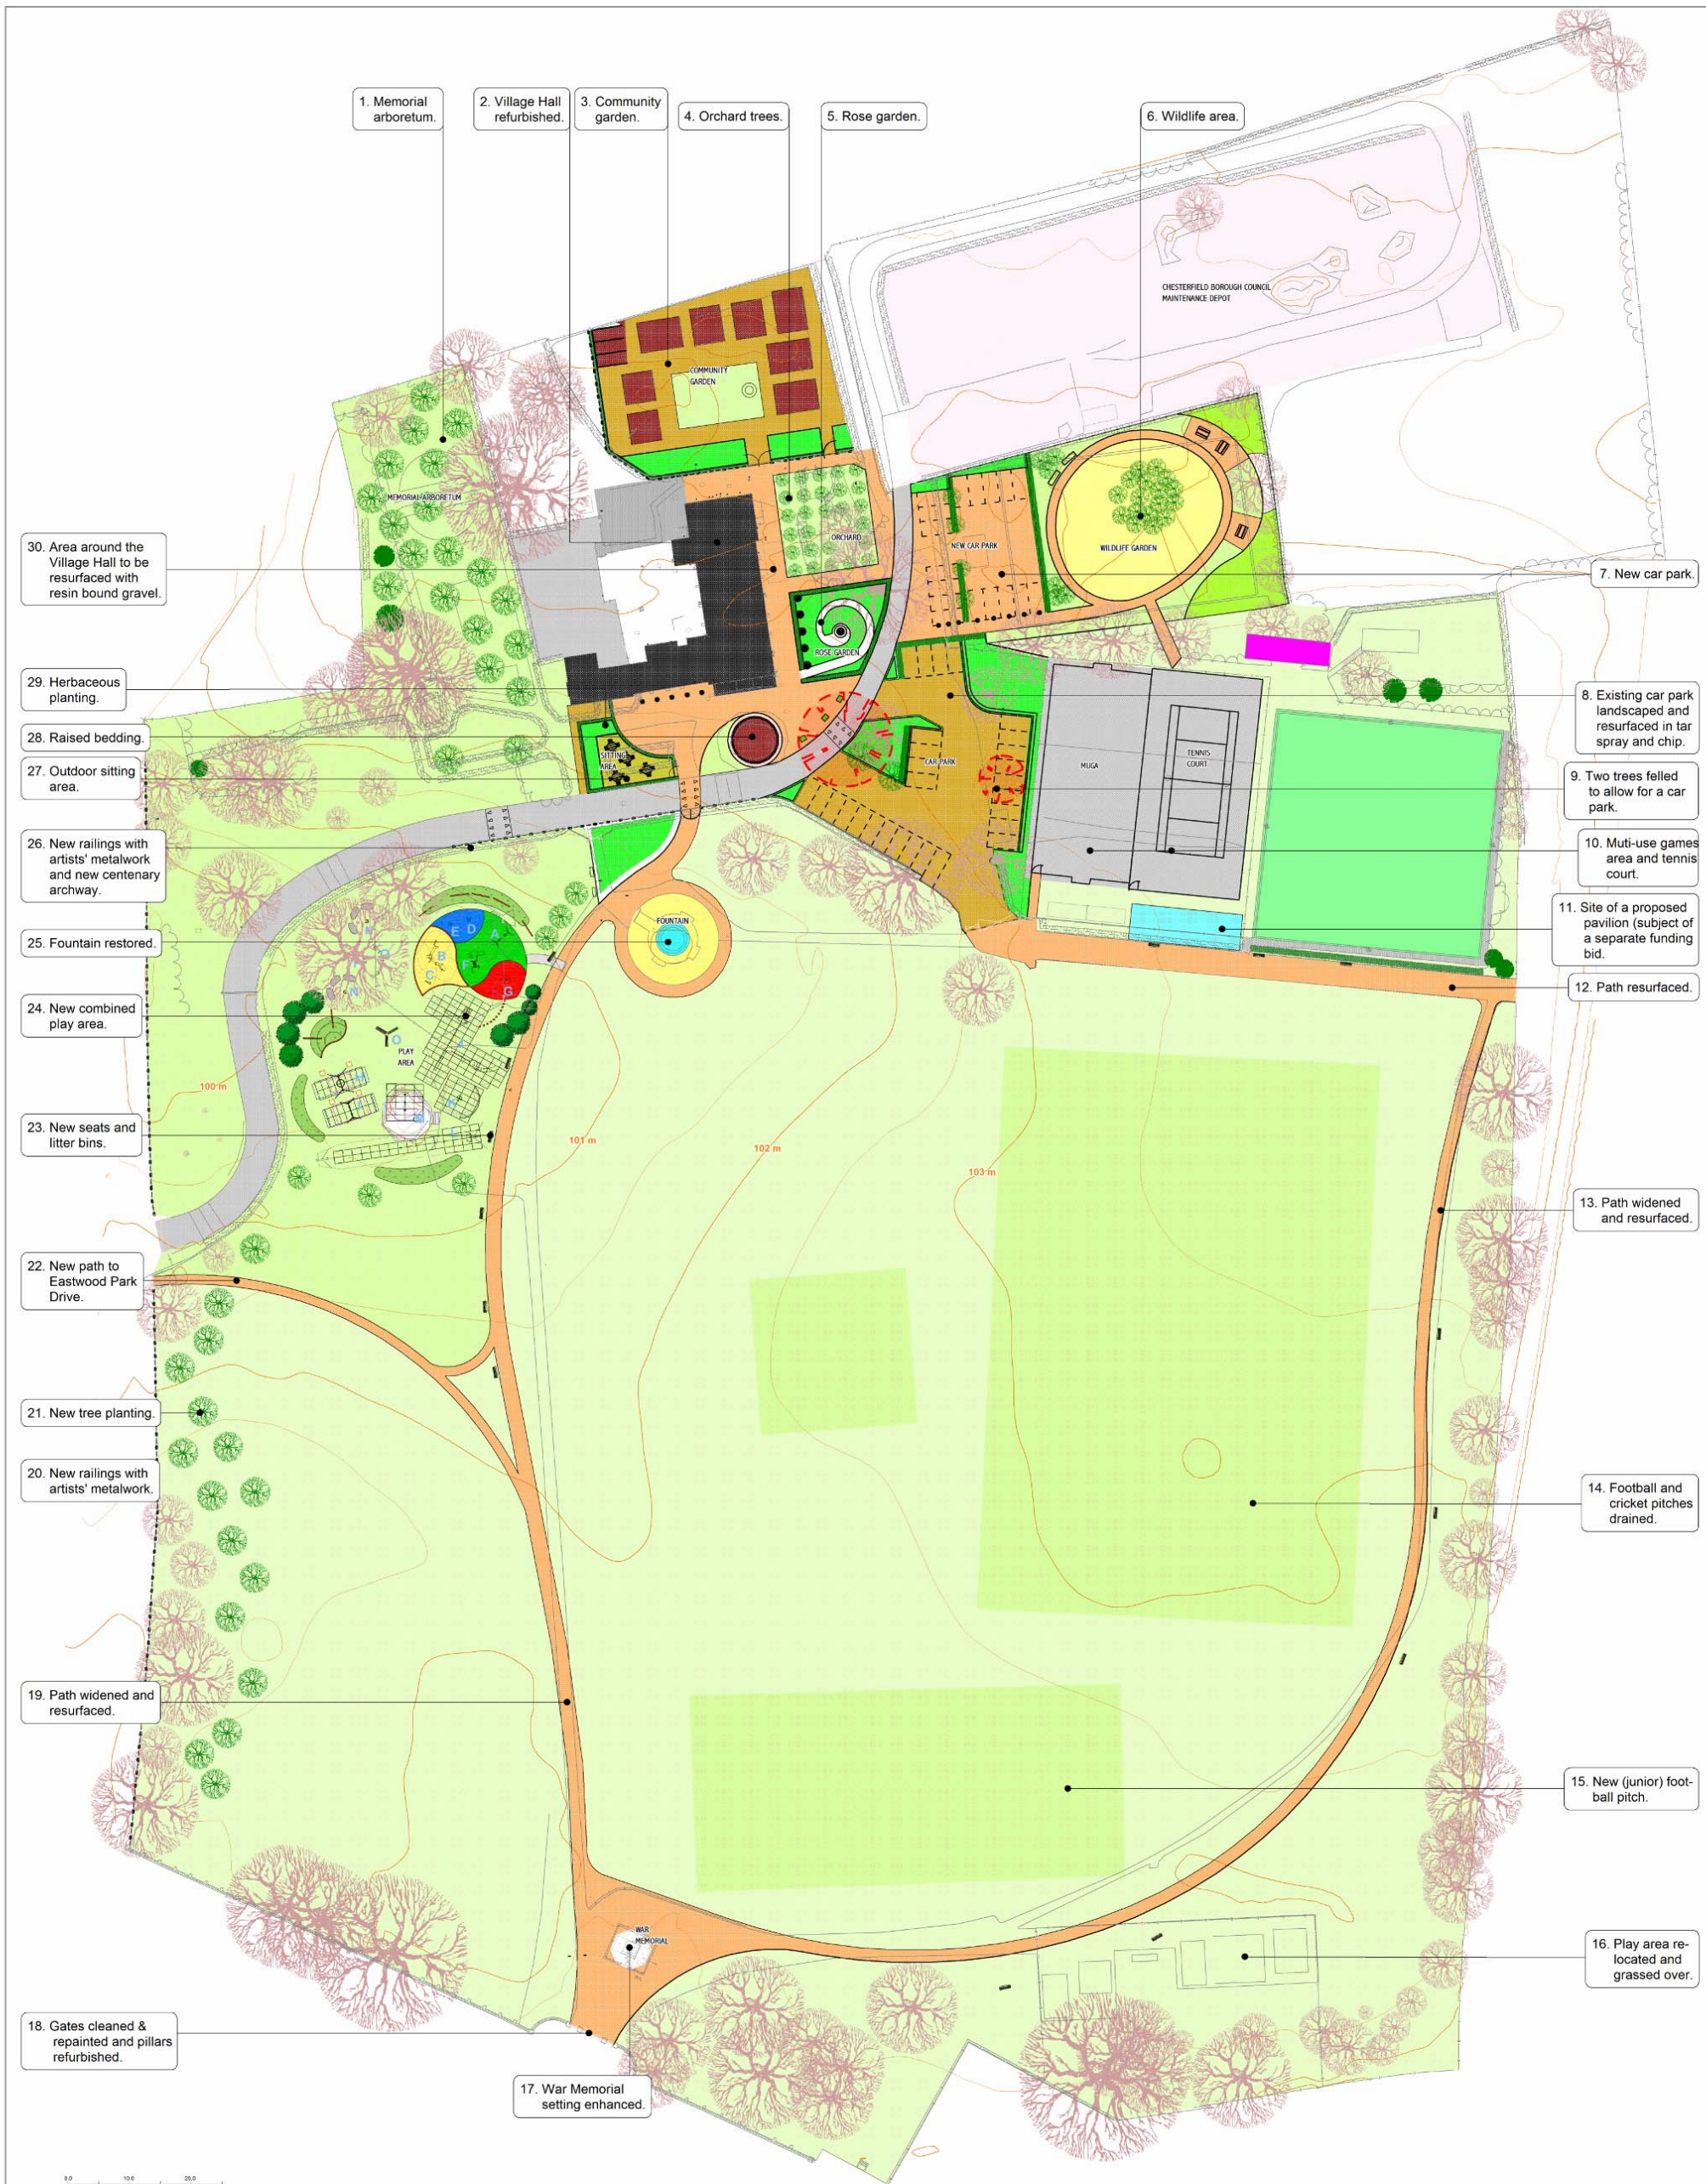
Eastwood Park: Masterplan

Date	Details	Revision
11/07/11	Various amendments including repositioning of the MGA & landscaping around the Village Hall.	-4
15/07/11	Reorientation of tennis court and MGA.	-5
12/09/11	Various amendments.	-6
23/09/11	Various amendments.	-7
24/10/11	Various amendments.	-8
12/12/11	Final amendments to correlate with contract drawings as issued on 12/12/11.	-9
26/01/12	Minor adjustments to the layout of the MGA & tennis court.	-10
