## **Refurbishment Survey (with MA only)**

**33 THE CRESCENT  
BRIMINGTON,  
S43 1AZ**

***Chesterfield Borough Council***

Job Number: J124650

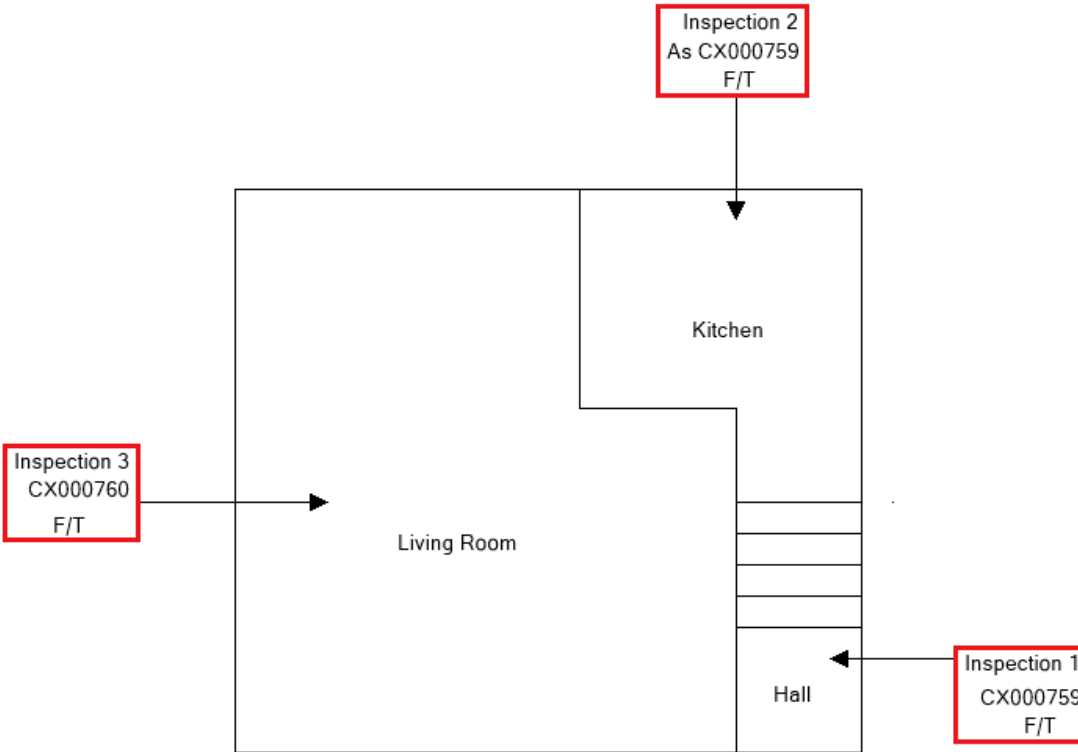
ARMSTRONG YORK ASBESTOS ENVIRONMENTAL LTD						Key	Identified ACM
Address	33 THE CRESCENT, BRIMINGTON			AY Number:	J124650		
Date:	28 Sep 2016	Floor	Ground Floor	Building	[Building] [BuildingDescription]		
Client:	Chesterfield Borough Council			Surveyor	John Dyche

Room Comments:	plasterboard ceiling new vinyl floor tiles to brown floor tiles to concrete brick and plaster walls
Sample Comments:	N/A
Total Assessment Score:	3
Risk Assessment Category:	Very Low
Recommendation:	Remove ACM if within the scope of works for refurbishment
