PRELIMINARY SITE REPORT (STRUCTURAL)

Site: Hady Hill Site, Spital, Hady, Chesterfield, S41 0BL

Ref: 23289_CBC-XX-XX-RP-S-1001

Project/Purpose: Development for New Housing Scheme

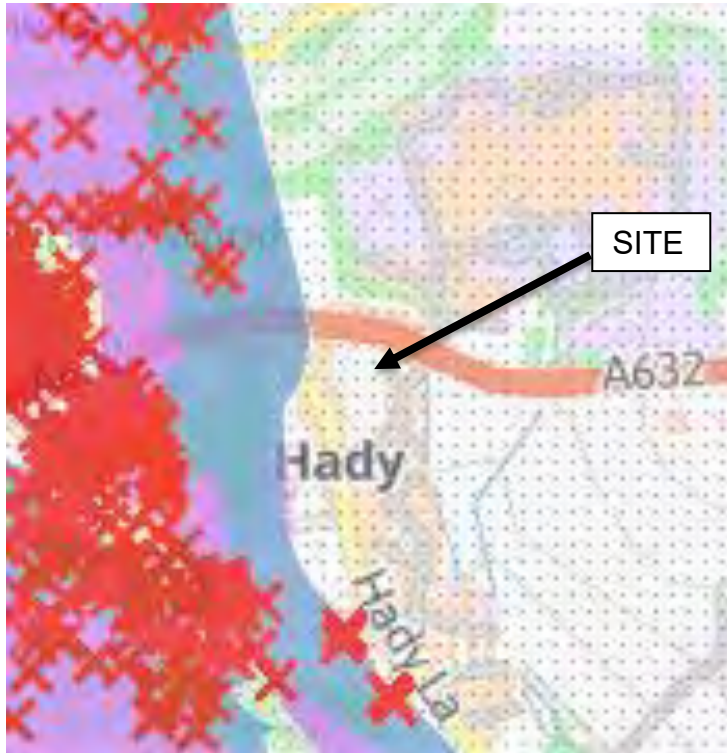
COAL AUTHORITY DATA

The site has not been checked with the Coal Authority. The Coal Authority database indicates that the site is within a coal mining reporting area but not located within a development high risk area. There are known workings and mine entries to the west of the site, but the site does not have known shallow workings identified within it. The risk of coal mining on site is considered to be low due to there being no outcrops of coal within the site due to the Brimington Anticline where the coal seams to dip and outcrop in the east and west of the ridge. The BGS Radon Mapping confirms the site is situated in a lower probability radon area.

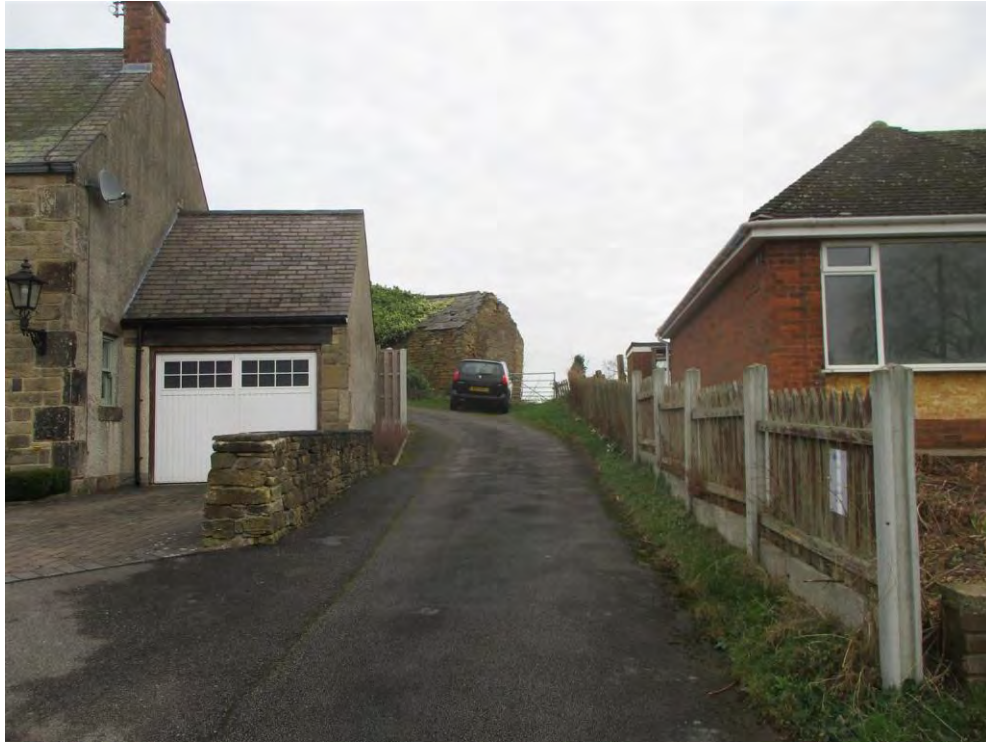
SITE ACCESS OFF HADY HILL

The site is currently a vacant overgrown area sloping down towards the south and the east. Currently access is via a gate in the south-east corner of the site off Hady Hill that forms a driveway to access 221 & 221A Hady Hill. There is a stone boundary retaining wall along the north side of the site retaining the site. There is also a bus pull-in adjacent the site on Chesterfield Road. There are a number of stacked tyres across the site that indicate that it may have been used for anti-social behaviour purposes.

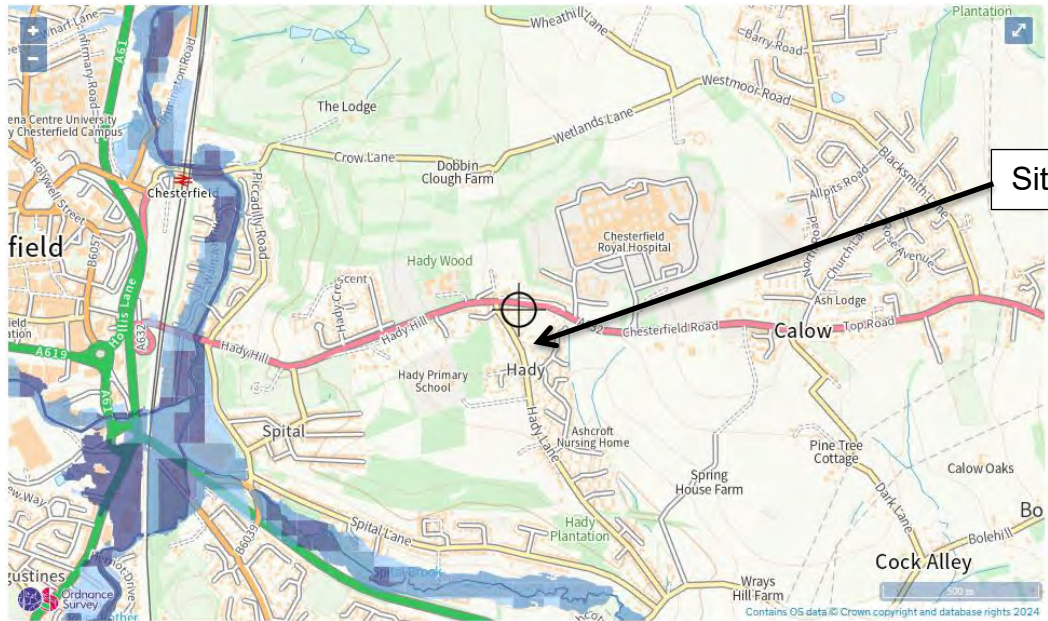
FLOOD RISK MAP

The site does not lie within an area depicted on the EA Flood Zone maps to be at risk of flooding from rivers or the sea. The site is not recorded to have an assigned risk for surface water flooding.

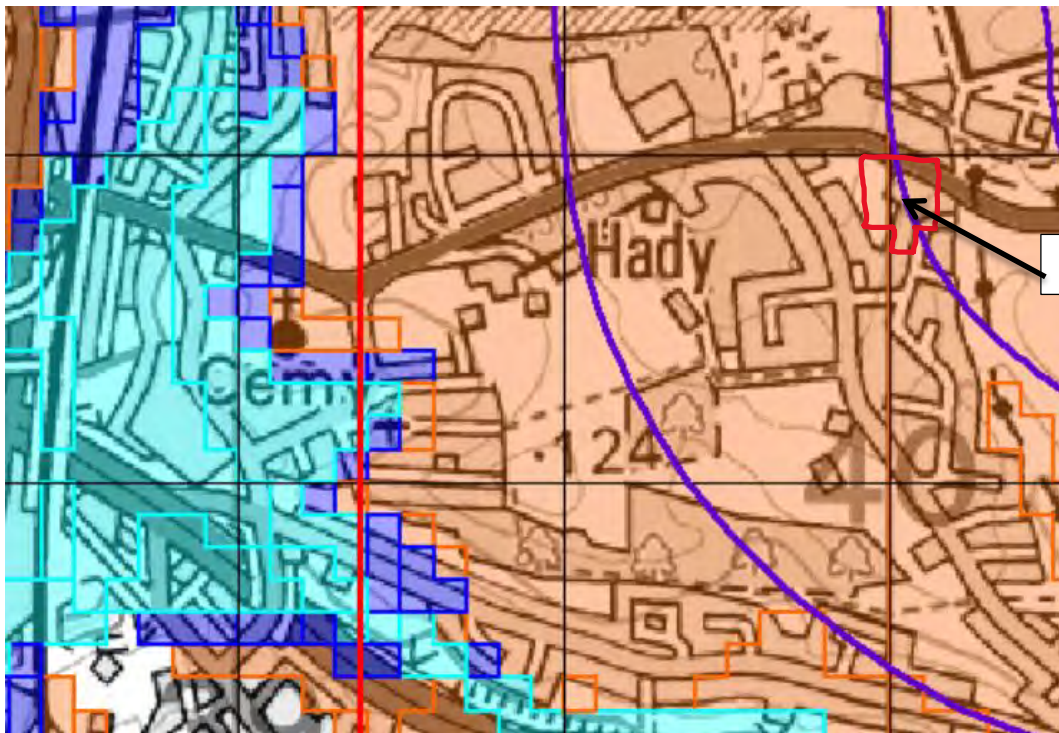
GROUNDWATER FLOODING VULNERABILITY

The British Geological Survey records the site is in an area of limited Potential for Groundwater Flooding to occur.
